REPORT OF THE ROAD SAFETY CAMERA COMMISSIONER TO THE MINISTER FOR POLICE AND EMERGENCY SERVICES

Investigation into the fixed road safety camera at the intersection of The Boulevard and Princes Highway, Norlane

Release date: 3 April 2014

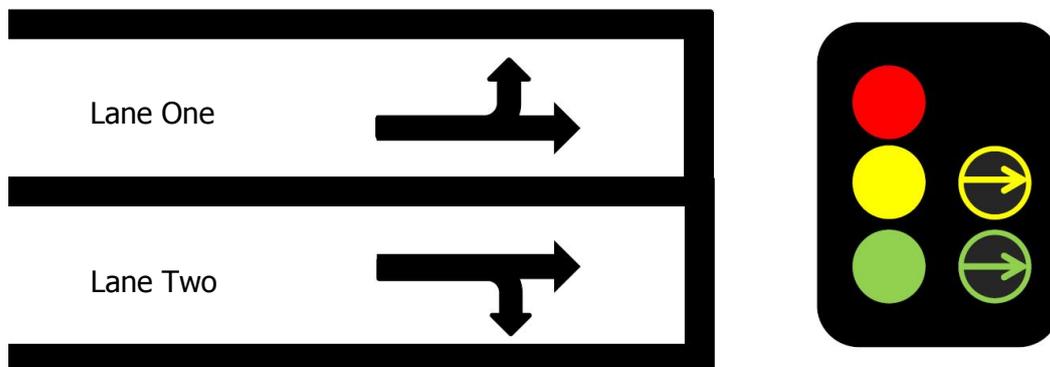
- 3 Originally, the traffic lights operated on what VicRoads terms "partially controlled" right hand turns, where there are no red arrows for right hand turns. **Figure One** shows the original lane and traffic light configuration. In this configuration, the yellow right turn arrow had a duration of three seconds and the yellow light for straight through traffic, was four seconds in duration.

- 4 This type of traffic light sequence allows vehicles to wait within the intersection to effect a right hand turn when there is no oncoming traffic from the opposite direction and where a single red light is used to prevent vehicles from proceeding through the intersection.

Figure One – The configuration of the lanes and traffic lights at the intersection of The Boulevard and Princes Highway until June 2012. **Note** - The traffic lights include partially controlled left turn arrows, however these are not included.

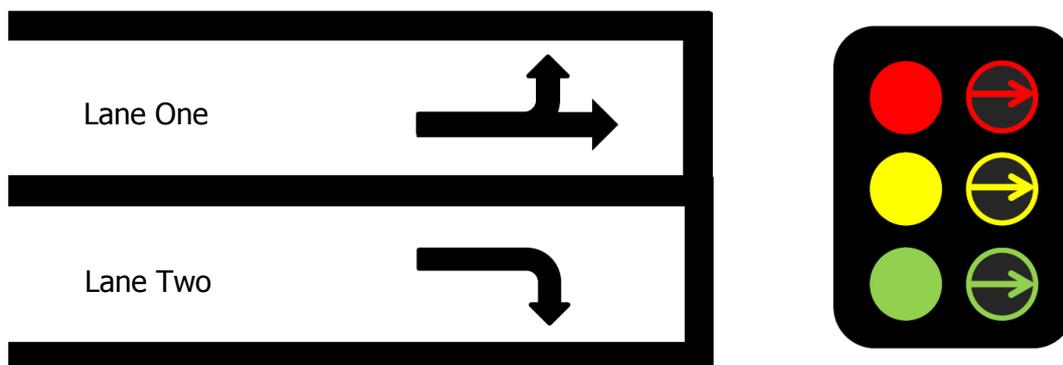
- 5 In June 2012, VicRoads made changes to the traffic light sequence and lane layout at the western approach of the intersection. **Figure Two** shows the lane and traffic light configuration. The changes were:
 - a. The right hand lane, Lane Two, was altered to be a right turn only lane, and
 - b. The right hand turn phase of the traffic light sequence changed to a "fully controlled" movement with the addition of a red right turn arrow.
- 6 The changes resulted in:

- a. The right hand turn arrows for east bound and west bound traffic operate to allow vehicles effecting a right hand turn to complete the manoeuvre safely, then
- b. The straight through movement for both east bound and west bound traffic operate to complete the cycle for traffic travelling along The Boulevard and North Shore Road.

Figure Two – The configuration of the lanes and traffic lights at the intersection of The Boulevard and Princes Highway from June 2012 until February 2014. **Note:** the traffic lights include partially controlled left turn arrows, however these are not included.

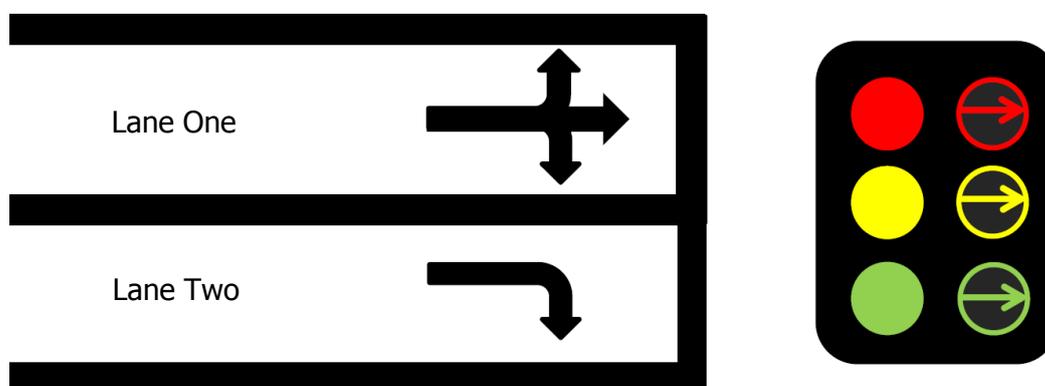
Figure Three – The configuration of the lanes and traffic lights at the intersection of The Boulevard and Princes Highway from 12 February 2014. **Note:** the traffic lights include partially controlled left turn arrows, however these are not included.

- 41** The changes consisted of an alteration to Lane One, enabling motorists to effect a right hand turn from both Lane One and Lane Two. To ensure this new lane configuration is safe, the traffic light cycle has been altered by:
- Allowing vehicles from The Boulevard to travel through the intersection in isolation, then
 - Allowing vehicles from North Shore Road to travel through the intersection in isolation.

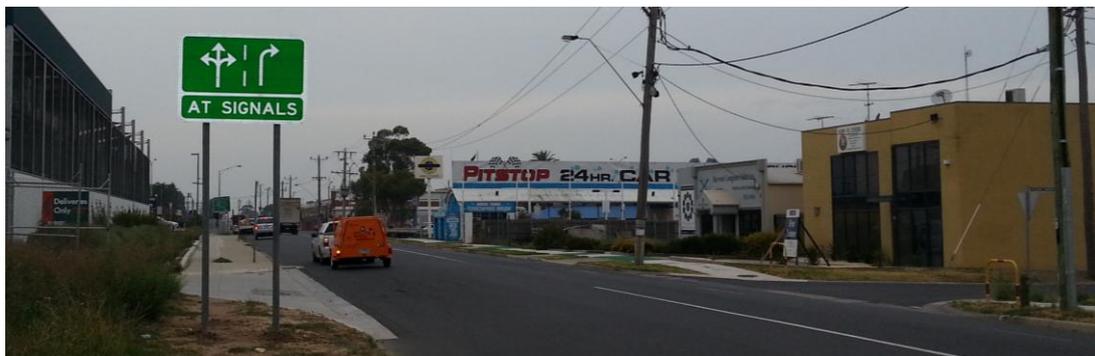
- 42 This change ensures the green and yellow lights and arrows are the same duration for both The Boulevard and North Shore Road. In effect, this allows more time for motorists to complete a right hand turn.
- 43 The change in lane markings is promulgated on approach to the intersection with a new sign, which is shown in **Figure Four**.

Figure Four – The new sign installed by VicRoads promulgating changes in lane markings on approach to the intersection. (Image credit: VicRoads)

- 52** I recommend that the adequacy of the signage recently erected by VicRoads as shown in **Figure Four** near the intersection of The Boulevard and Princes Highway in Norlane be monitored, particularly in respect of the apparent awareness of motorists of the availability of the left lane to effect a right hand turn.

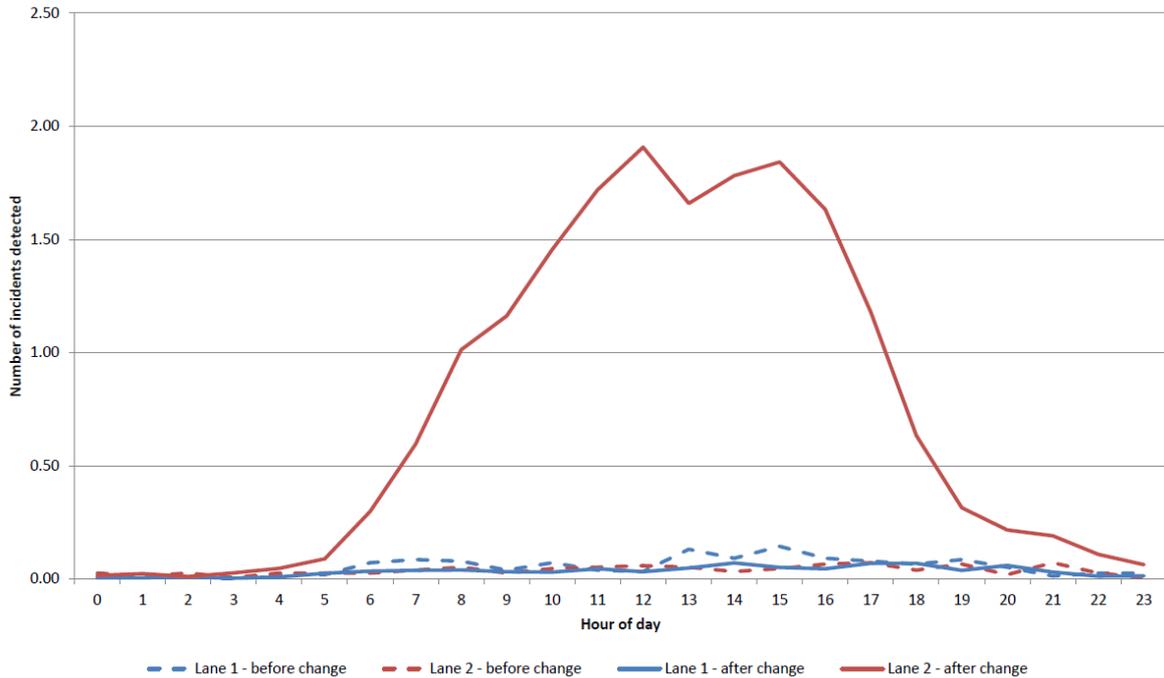
- 35** **Figure C1**, contained in **Appendix C** shows the average number of incidents detected by the road safety camera per hour for each lane before and after the change made by VicRoads. The results have been normalised over the two periods during which they were recorded. As shown in **Figure C1**, the number of incidents detected remains at a low level for Lane One. However, the number of incidents detected in Lane Two has dramatically increased as a result of the changes implemented by VicRoads.

Figure C1 – average number of incidents per hour for each lane before and after the initial change in the traffic light sequence implemented by VicRoads

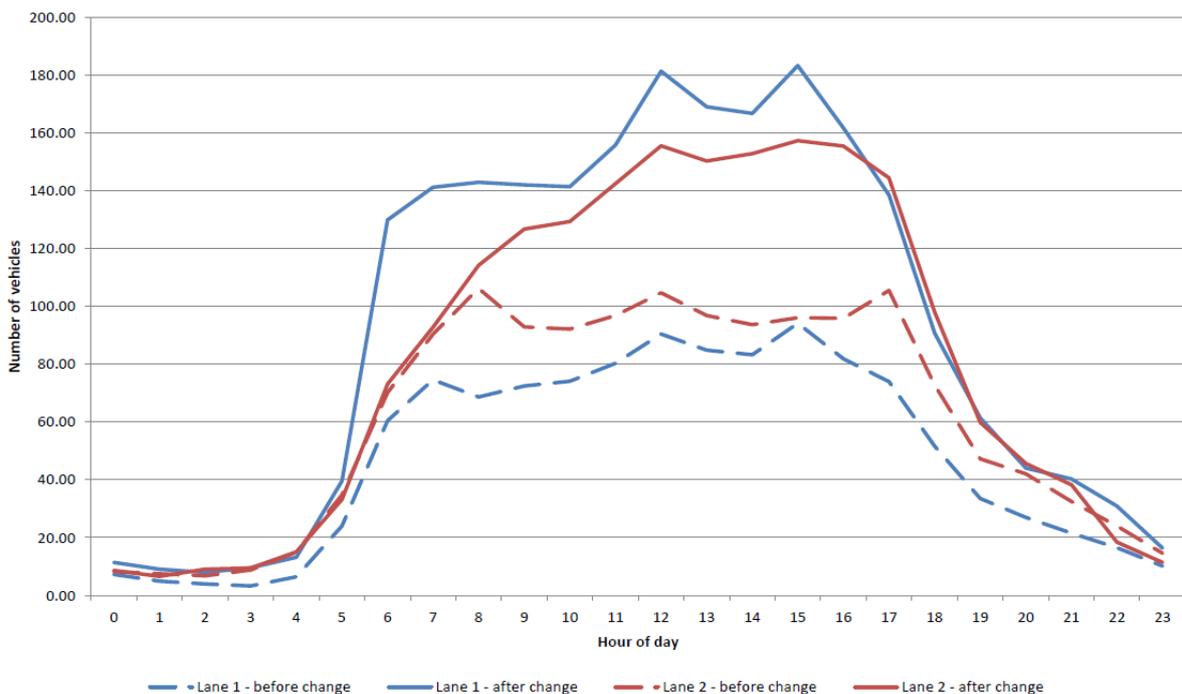
- 36** To understand the reasons behind this increase in the number of detected incidents, the change in traffic volume was also examined. **Figure C2**, contained in **Appendix C**, shows the change in average traffic volume per hour before and after the changes implemented by VicRoads.

- 37** The data shows that the average daily traffic volume has increased by approximately sixty per cent since the implementation of changes to the intersection. However, the number of incidents detected by the camera has increased approximately nine-fold, with Lane Two accounting solely for the increase. The increase in detected incidents cannot be explained by the increase in traffic volume alone.

Figure C2 – average traffic volume per hour for each lane before and after the initial change in the traffic light sequence implemented by VicRoads

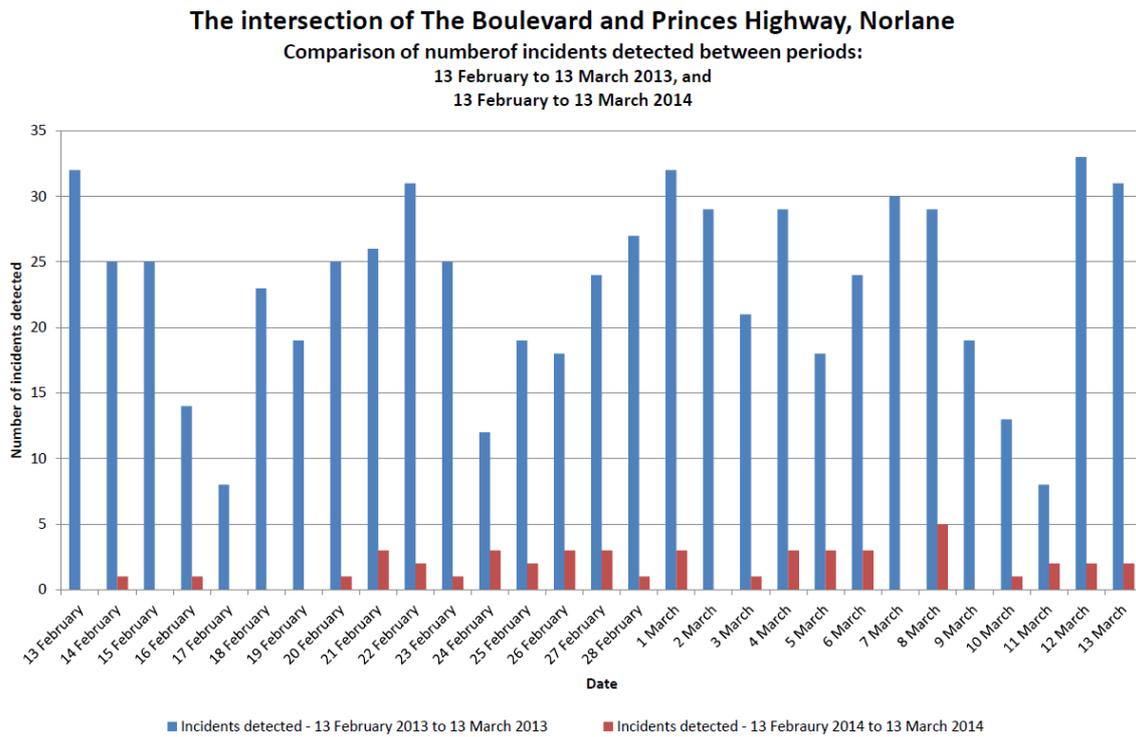
- 44 Analysis of data recorded by the road safety camera since this most recent change shows that the number of vehicles entering the intersection against the red arrow, has decreased dramatically. Data recorded by the fixed road safety camera during the period 13 February 2014 and 13 March 2014 shows that the highest number of incidents detected on one day was five. **Figure C3** contained in **Appendix C** compares the daily number of incidents detected by the road safety camera for both lanes during the periods 13 February to 13 March 2013 and 13 February to 13 March 2014.
- 45 I am confident that the effect of this latest change to the traffic light sequence and operation of the intersection will be a continued reduction in the number of incidents detected made by the road safety camera.

Figure C3 – comparison of number of incidents detected by the road safety camera before and after the most recent traffic light sequence implemented by VicRoads
