REPORT OF THE ROAD SAFETY CAMERA COMMISSIONER TO THE MINISTER FOR POLICE

Investigation into four fixed road safety cameras operating in 40km/h speed limit zones

Release date: 23 July 2015

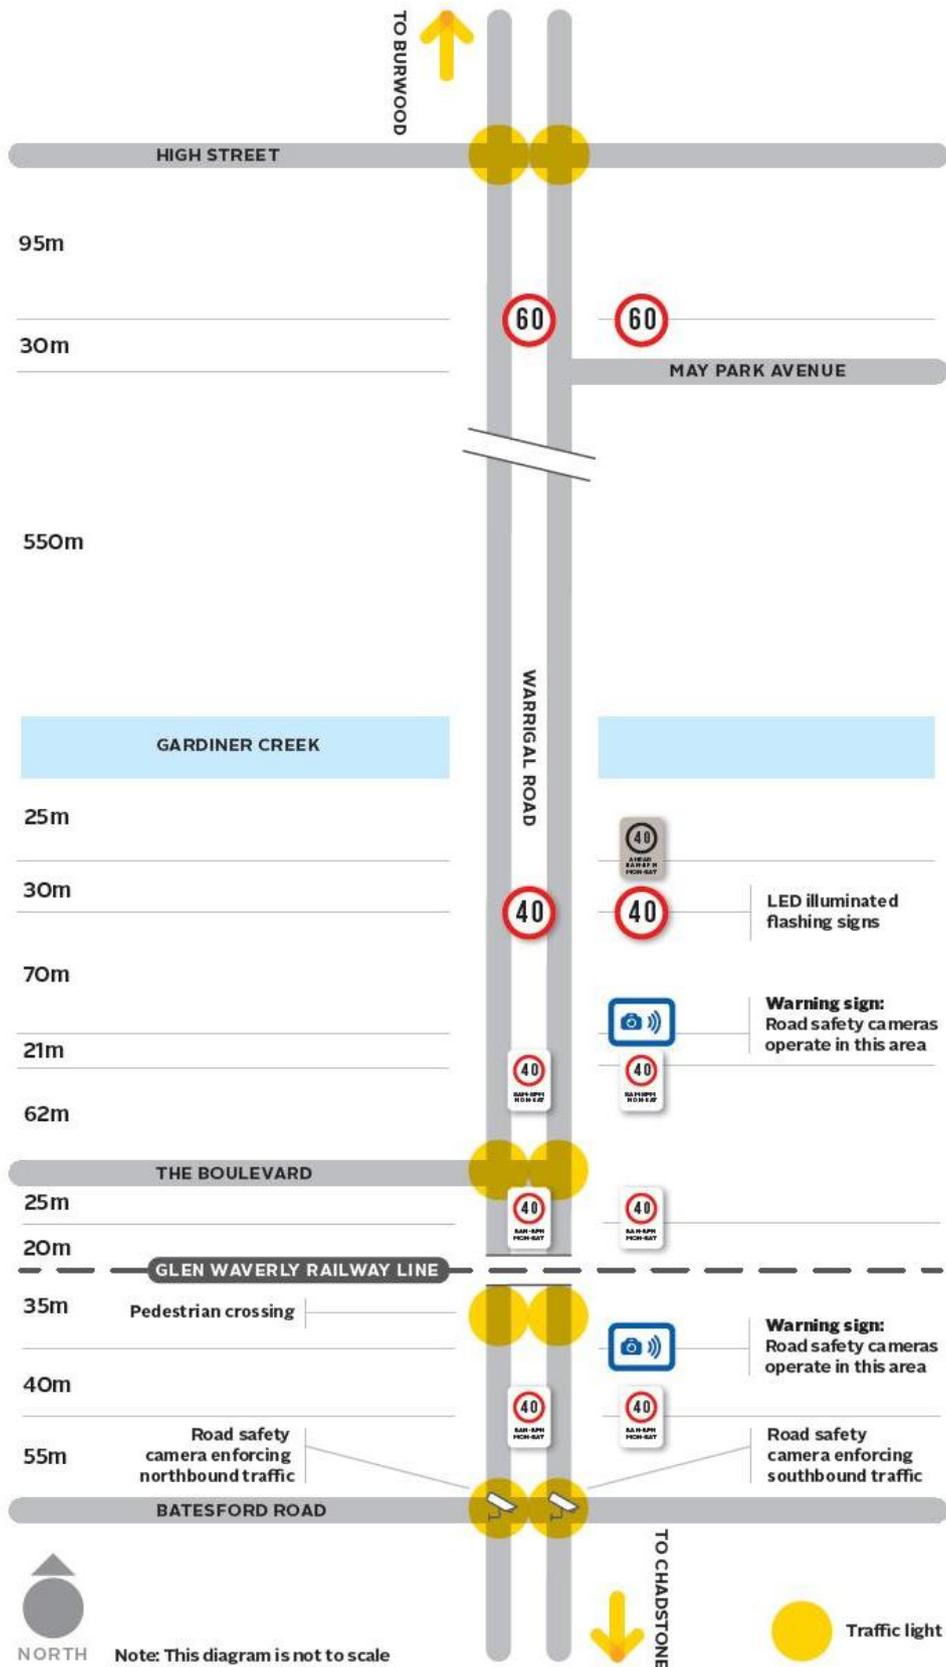
DIAGRAM OF SIGNAGE ALONG WARRIGAL ROAD, CHADSTONE

On 27 October 2014, VicRoads installed a further set of two speed limit signs between the railway bridge and the road safety camera, bringing the total number of speed limit signs promulgating the variable speed limit to eight. A diagram of the area, including speed limit signage, can be found in **Appendix B**.

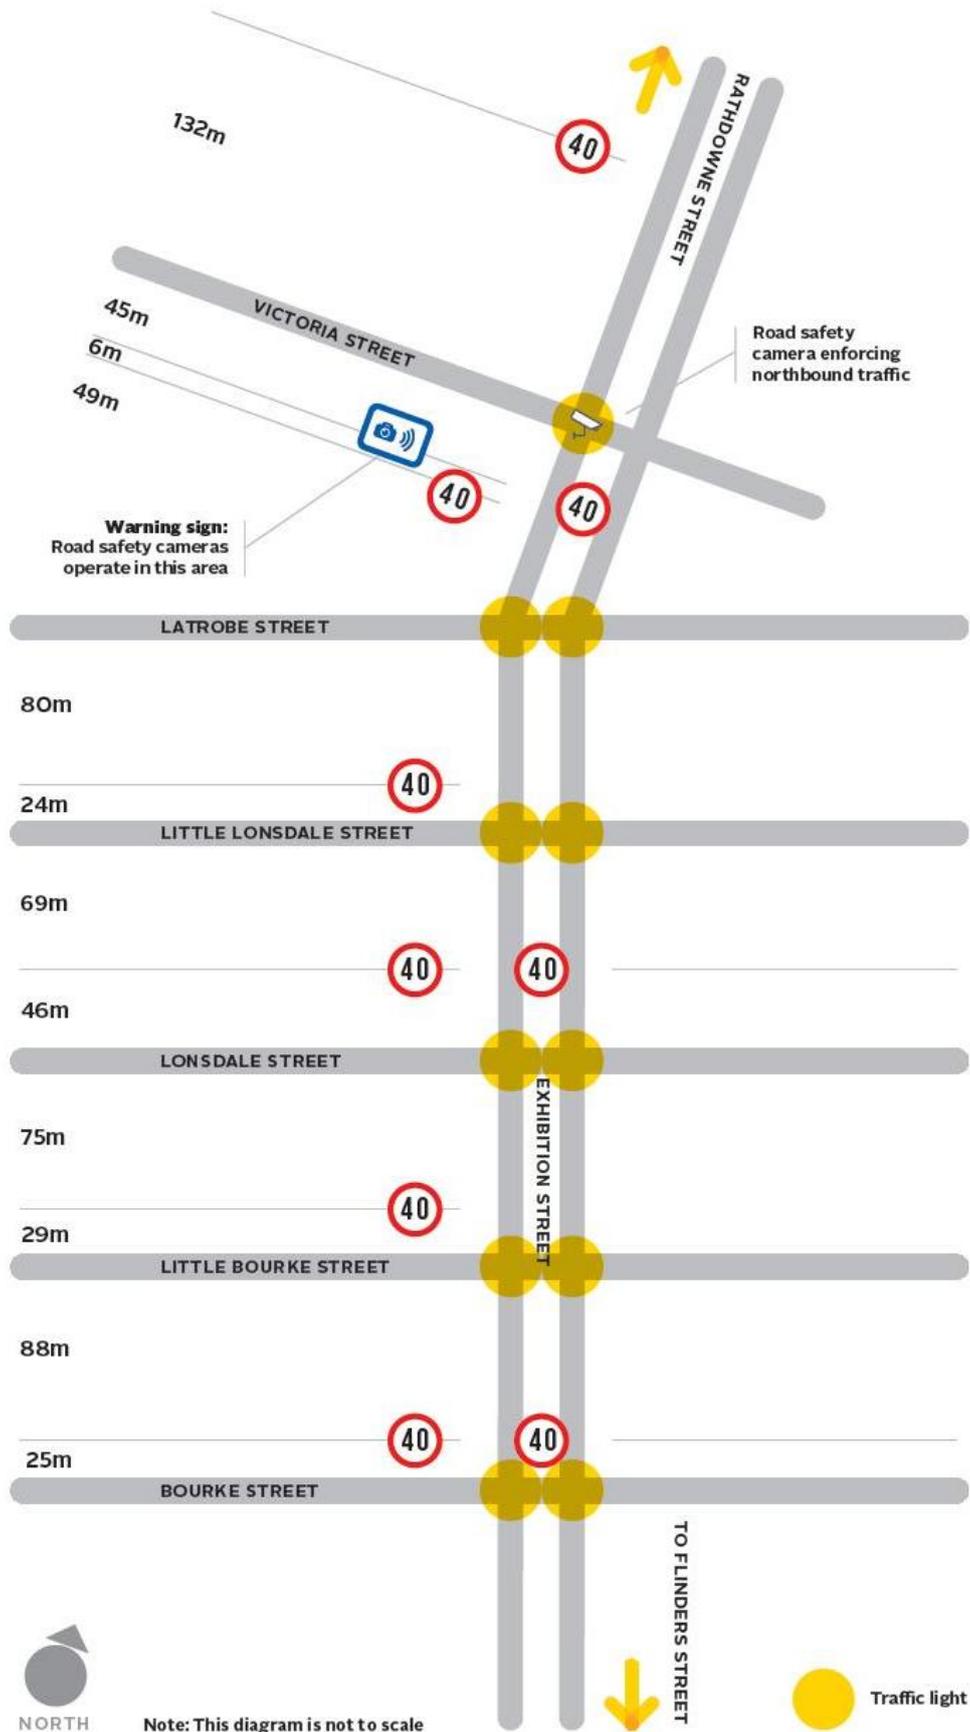
DIAGRAM OF SIGNAGE ALONG EXHIBITION STREET, MELBOURNE

A member of my technical staff visited this site on 30 March 2015 and confirmed that eight speed limit signs are installed along Exhibition Street, between Bourke Street and Victoria Street. A diagram of the area is found in **Appendix B**.

7. Concerning the length of road along Exhibition Street, on approach to the intersection with Victoria Street, I recommend the static speed limit signs immediately preceding the road safety camera be replaced with flashing, LED illuminated signs, and
8. All current speed limit signage leading into the City of Melbourne's 40km/h speed limit area should be replaced with flashing, LED illuminated versions of those signs for additional visibility. In short, it should not be possible to enter the CBD by motor vehicle without being confronted by at least one flashing, LED illuminated 40km/h speed limit sign. I believe these steps would make hollow any complaint by a motorist that they were unaware of the relevant speed limit.

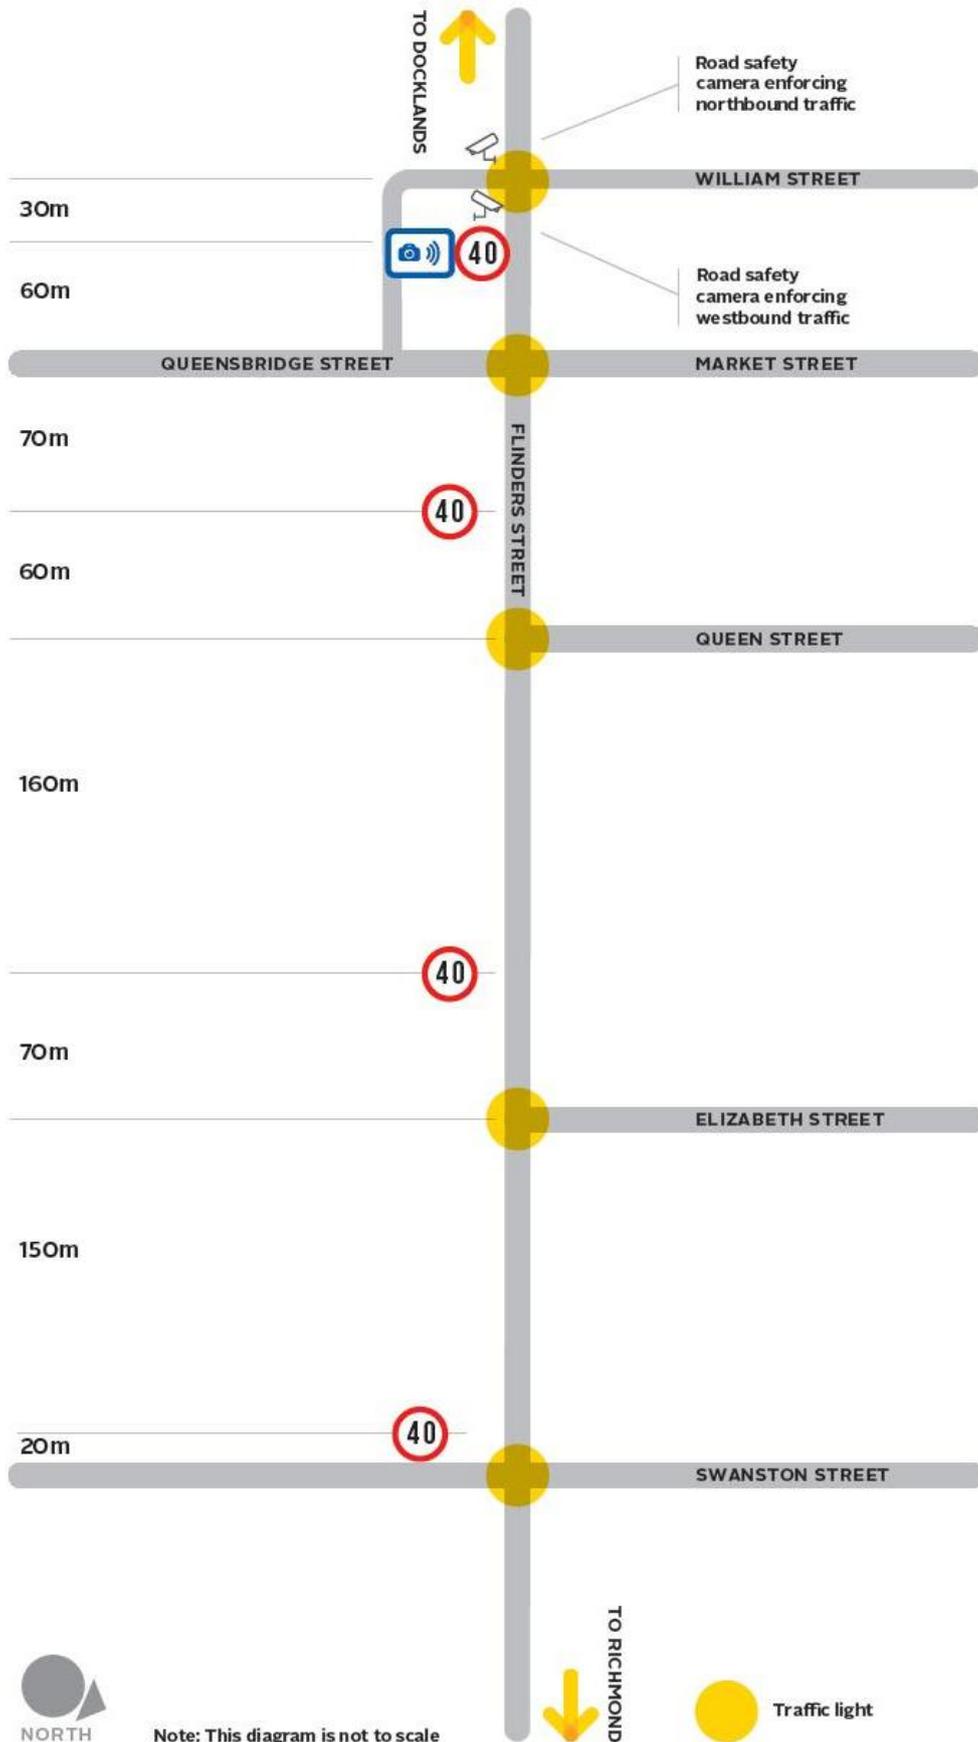
DIAGRAM OF SIGNAGE ALONG FLINDERS STREET, MELBOURNE

A member of my technical staff visited this location, and noted there are four speed limit signs installed on Flinders Street, between Swanston Street and William Street. A diagram of the area is included in **Appendix B**.

6. Concerning the length of road along Flinders Street, on approach to the intersection with William Street, I recommend that the static speed limit sign immediately preceding the road safety camera be replaced with a flashing, LED illuminated sign,

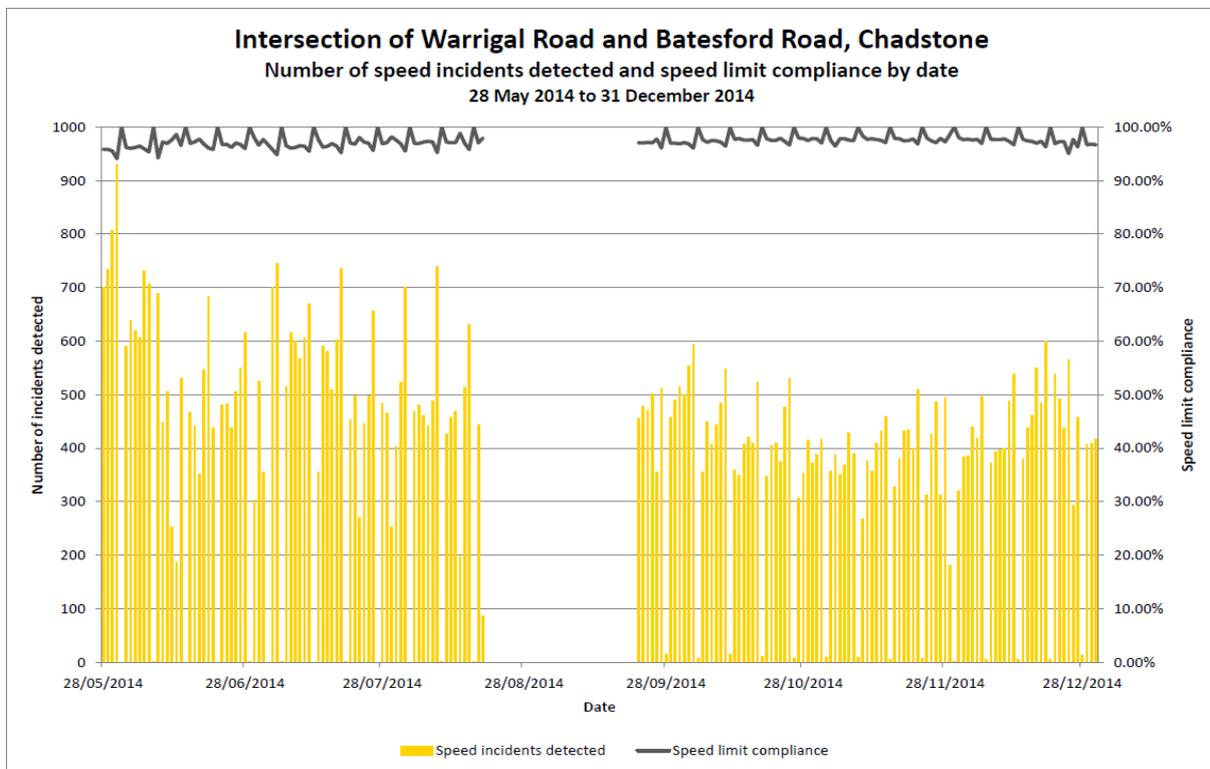
These diagrams show that the weekly traffic volume pattern remains relatively consistent, with a peak in traffic volume from winter to just before Christmas, before falling away dramatically. The data also shows a downward trend in the number of vehicles detected exceeding the speed limit throughout this period. It must be noted that due to the nature of the variable speed limit along Warrigal Road, very few speed incidents were recorded on Sundays, as can be seen in **Figure C1.2**.

Figure C1.2 – Daily number of speed incidents recorded at the intersection of Warrigal Road and Batesford Road, Chadstone.
