**Road Safety
Camera
Commissioner**

**REPORT TO THE MINISTER FOR
POLICE ON THE ROAD SAFETY
CAMERAS AT LODERS RD BRIDGE,
PENINSULA LINK**

04 October 2018

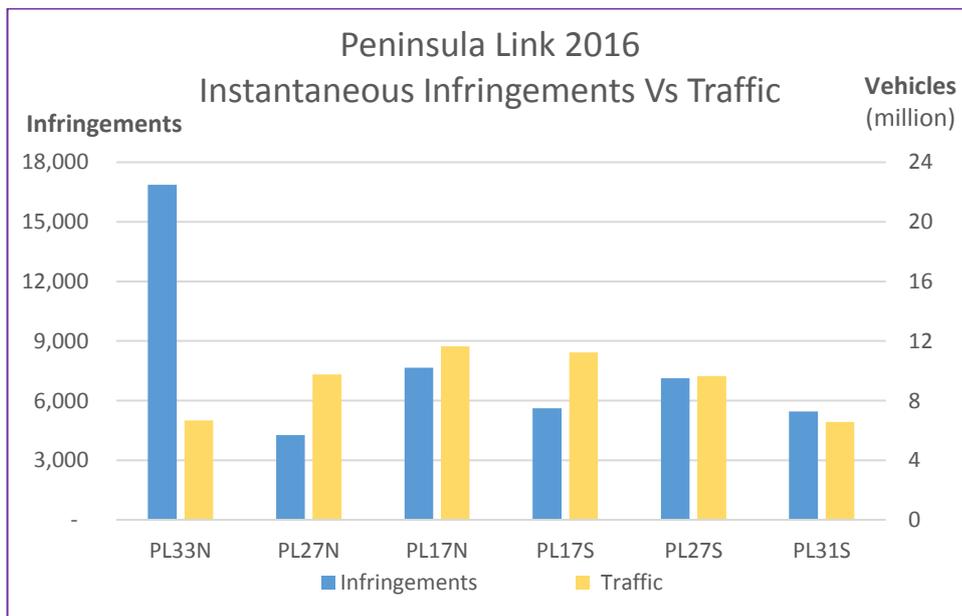
Figure 1

- 13 **Figure 1** shows a set of pairs of data, being the number of infringements (left axis) and number of vehicles comprising the traffic (right axis). The pairs of columns show the numbers of vehicles paired with the number of infringements for each of the six instantaneous camera sites. It identifies what at first blush appears to be the out-of-proportion nature of infringements at “PL33N”, Loders Road Bridge. This was what I wanted to revisit to ensure as best I can the integrity accuracy and efficiency of the road safety camera system at PL33N; on Peninsula Link at Loders Road Bridge for inbound traffic.

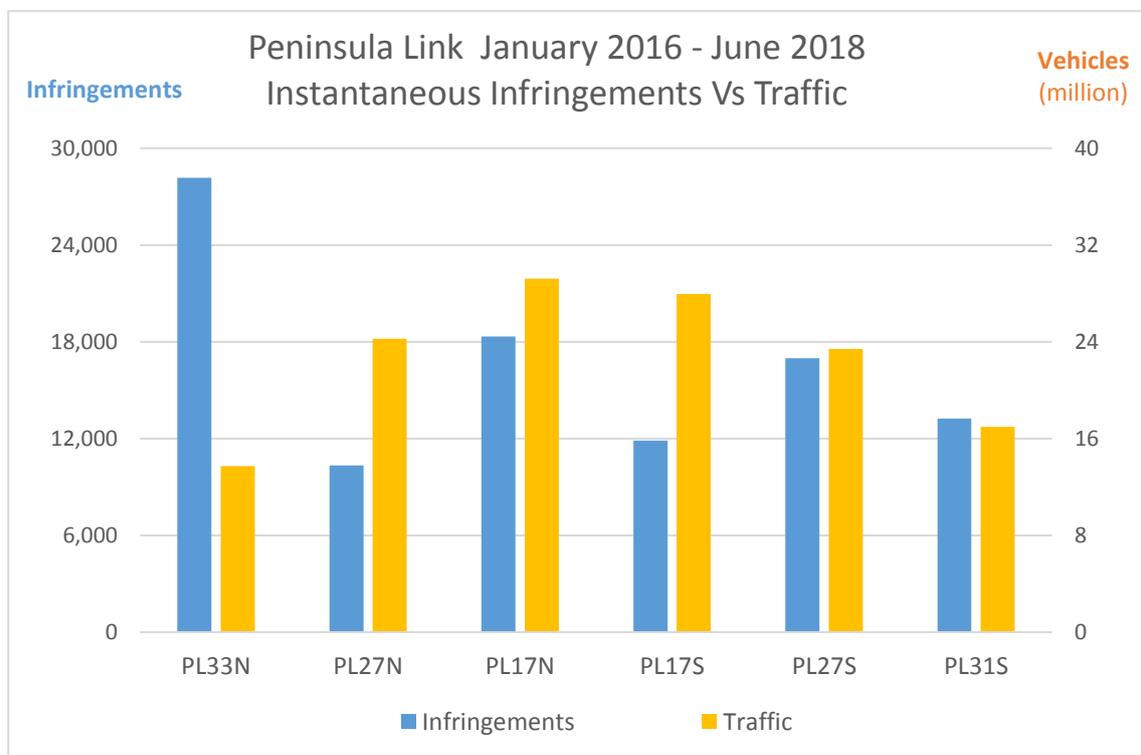
Figure 2

- 19 While it appears from the above graphs that PL33N is 'overrepresented' in infringement numbers, particularly in instantaneous infringements, it is worth noting that PL33N generated zero infringements in eleven of the thirty months considered. If infringements in that eleven month period had occurred at the same rate then PL33N's infringement numbers might have been more than 40% higher than as shown.

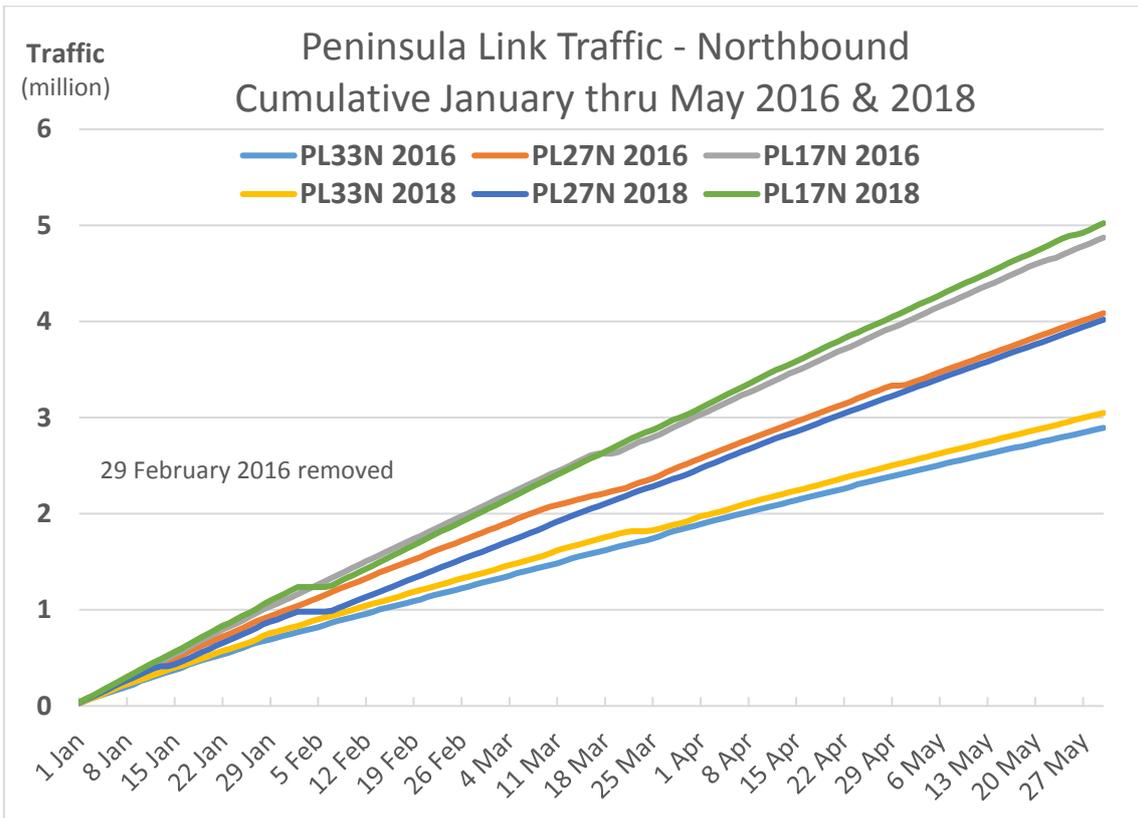
Figure 4

- 22 The graphs show that the slope of each 2016/2018 pair is essentially identical at each site. That is, the camera sites are recording similar volumes over two similar periods two years apart. Further, they are showing a decline in the level of infringements; more vehicles using the road, but fewer vehicles speeding. **This is a noteworthy road safety message.**

24 Some flatlines as appear on the graphs, such as around late January/early February, represent periods where cameras were experiencing downtime.

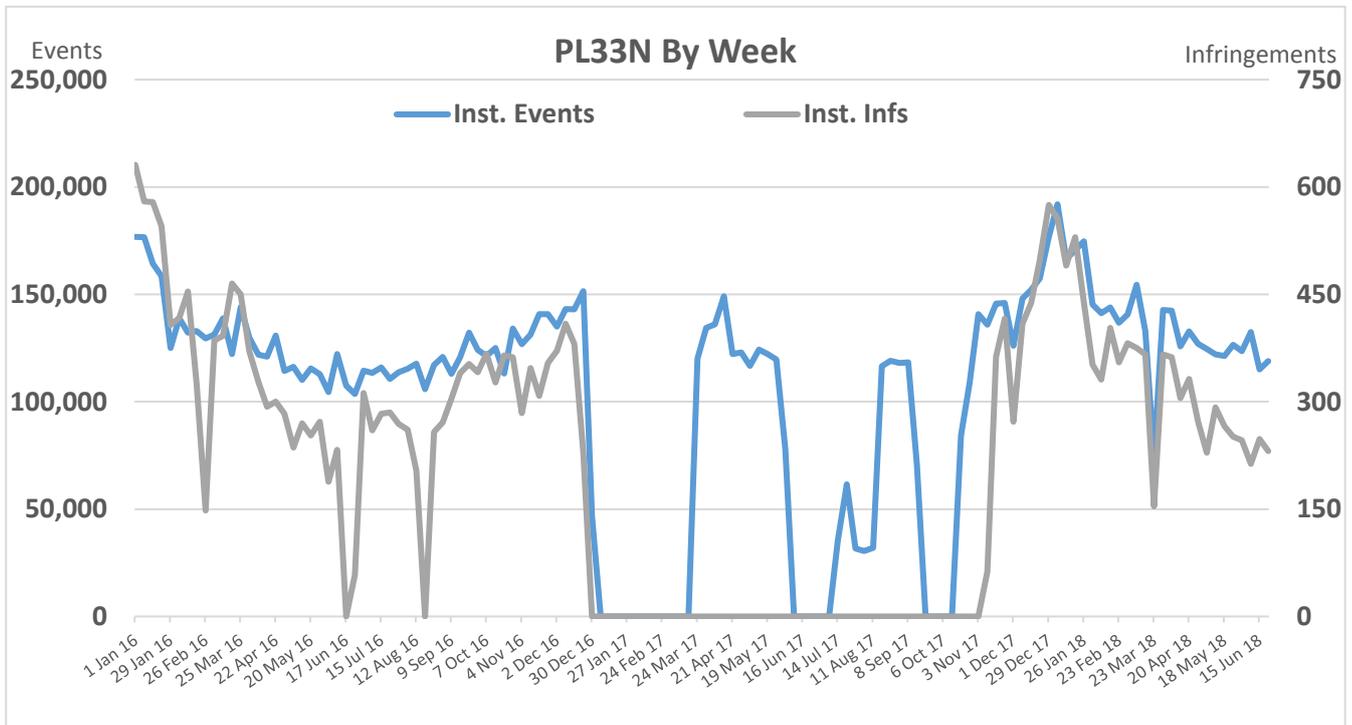
Figure 6

25 **Figure 6** is a graph which contrasts incidents from which an infringement could potentially be issued against actual infringements issued for PL33N, Loders Road Northbound. To avoid confusion (and to avoid an unnecessarily noisy graph) **only instantaneous** events and incidents are displayed. The graph does not contain point-to-point incidents. After the vandalism in late December 2016, PL33N appears to have become operational again in mid-March 2017. Site acceptance and recommissioning was completed in mid-November 2017.

26 It is clear from the above that, despite the site functioning from late March 2017, delays in recommissioning meant that many thousands of likely infringements were forgone. PL33N generated 16,708 instantaneous infringements in 2016, but only 2,695 in 2017. The opportunities for correcting poor driving behaviour, in accordance with *Towards Zero*, were lost during this period.

- 33** That the Department of Justice and Regulation's newly-created Road Safety Camera Program Unit investigate the reasons for the delay in recommissioning the site on Peninsula Link at Loders Road bridge with a view to ensuring ongoing improved efficiency of the road safety camera system.
- 34** I make no other recommendations in relation to this report.
