# REPORT OF THE ROAD SAFETY CAMERA COMMISSIONER TO THE MINISTER FOR POLICE AND EMERGENCY SERVICES

Investigation into the fixed road safety cameras at the intersection of  
Springvale Road and Lower Dandenong Road, Braeside

**Release date: 10 March 2015**

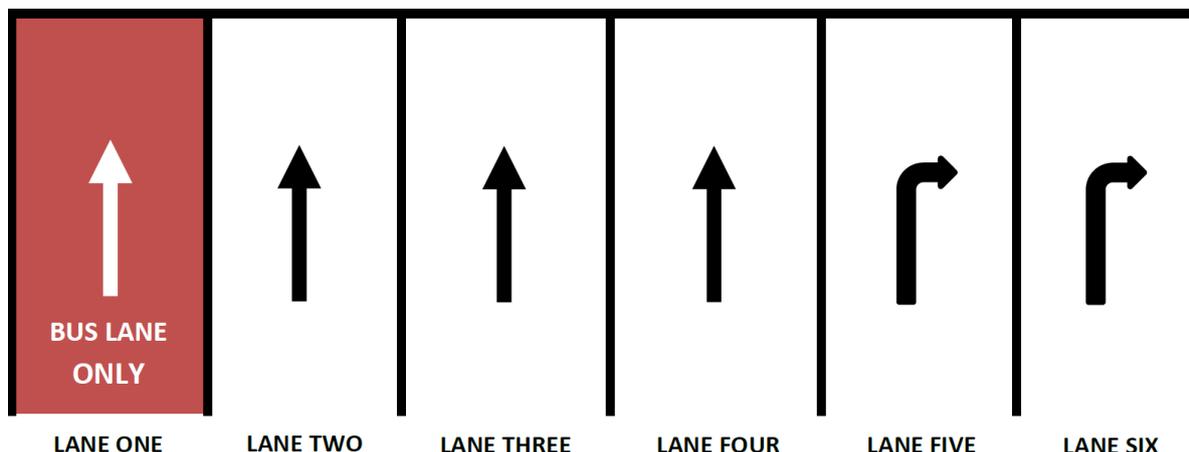
**Figure One** – lane layout for the northbound carriageway of the intersection of Springvale Road and Lower Dandenong Road, Braeside

- 4 Due to the large number of lanes at this intersection, two fixed road safety cameras are present, one on the kerbside and one on the median strip dividing the two carriageways. The kerbside camera is dedicated to monitoring vehicles travelling through the bus lane, and the two straight through lanes immediately adjacent to the bus lane. The remaining lanes are monitored by the camera in the median strip. **Figure One**, below, shows the layout of the lanes.

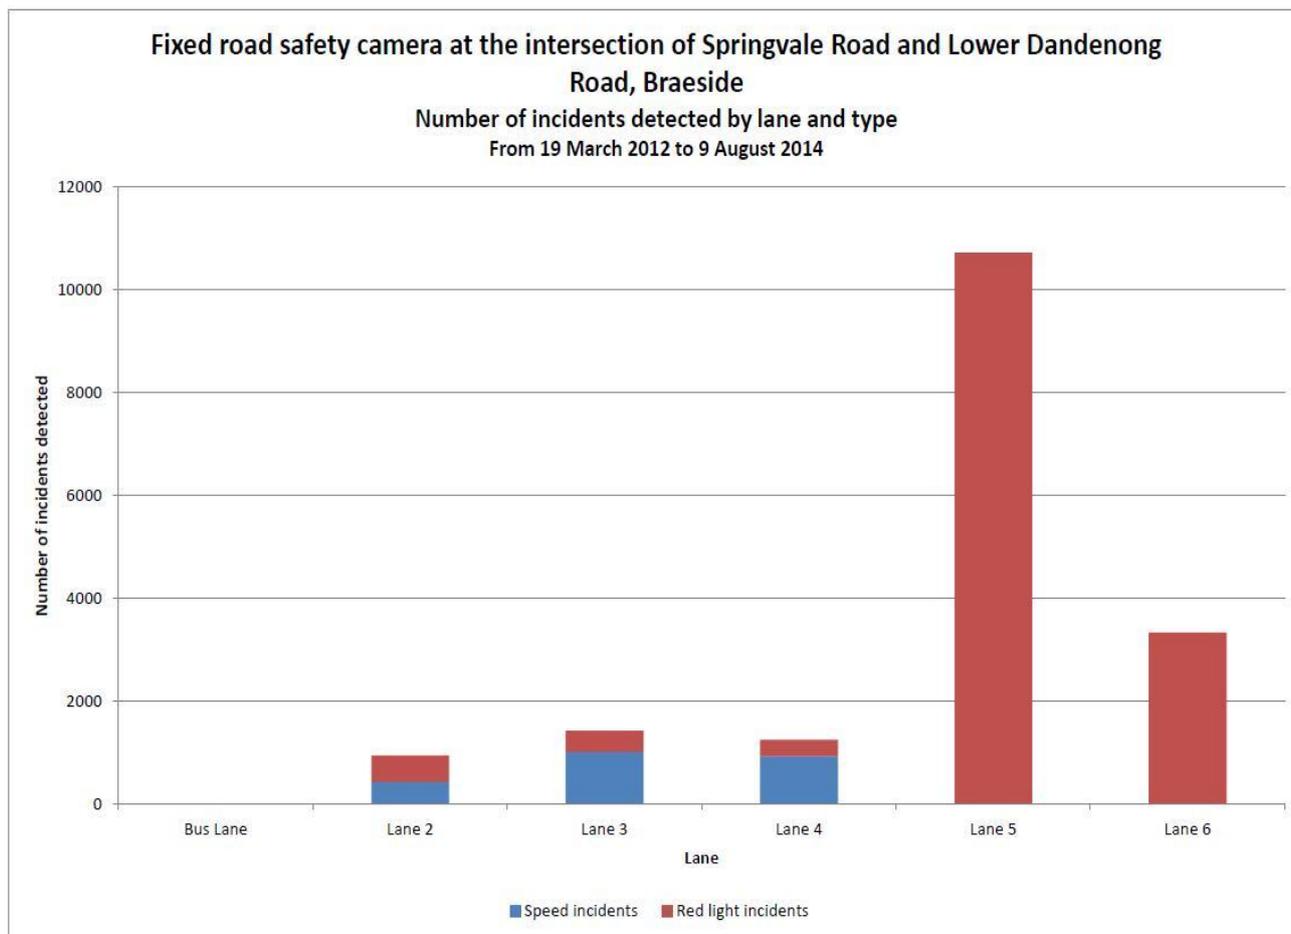
**Figure Two** – number and type of incidents detected per lane during the period 19 March 2012 to 9 August 2014

- 22** Analysis of the data recorded by the road safety cameras showed that for the period 19 March 2012 to 9 August 2014, 11,772,143 vehicles were detected travelling north along Springvale Road or turning right into Cheltenham Road. **Figure Two** shows the number, type and proportion of incidents detected by the road safety cameras in each lane.

**23** The two road safety cameras detected 17,640 speed and red light incidents during this period. The rate of compliance with the speed limit and the traffic signals at this site was approximately 99.85% of all traffic. **Table One** shows the traffic volume compared to incidents detected. For the purposes of this report, the Bus Lane will be ignored, since no incidents were detected in this lane.

- 24** The data shows that the two right turn lanes, Lane Five and Lane Six have the highest ratio of detected incidents to traffic volume. As all of the complaints referred to me have related to red light infringements involving right hand turns at this intersection, this report's main focus is upon this aspect of the intersection and the operation of the road safety cameras.
