REPORT TO THE MINISTER FOR POLICE ON THE MALWARE INFECTION TO THE FIXED DIGITAL ROAD SAFETY CAMERA SYSTEM

3 May 2018

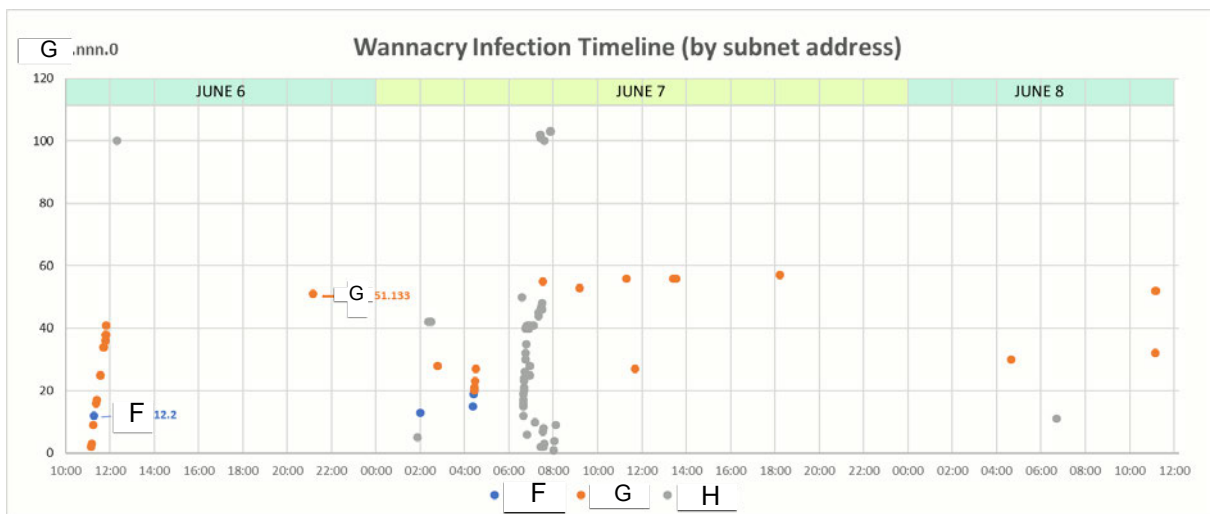
Figure 1 – WannaCry Infection Timeline (by subnet address)

83 Infection Timeline depicted in Figure 1 shows the date and time of the earliest log entry for each **infected** machine on each subnet. It signposts the largely sequential nature of attacks. The vertical address reports the value of the third IP address chunk. For example, the 21:10 infection of   G   .**51**.133 is plotted in orange with a vertical value of 51.

- it matches the date and time of first previously known infections, and

- it contradicts an earlier analysis of the spread of the virus which had been based on file time stamps. The previous analysis had considered the infection took two weeks to complete but analysis of the Windows logs showed it took 48 hours.

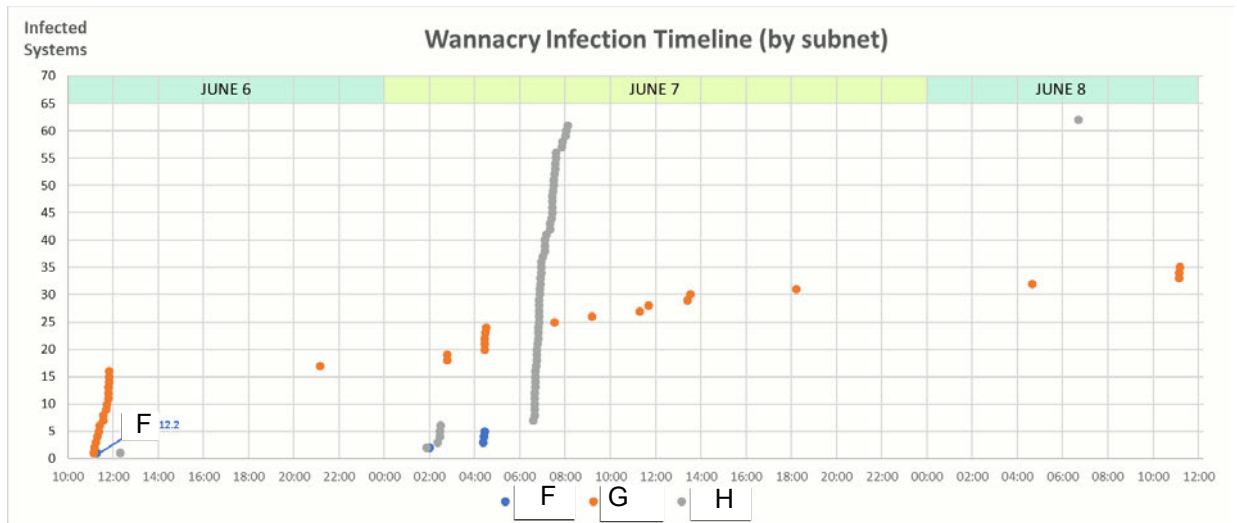
Figure 2 – WannaCry Infection Timeline (by subnet)

88   Figure 2 depicts the date and time of the earliest log entry for each infected machine on each subnet. It demonstrates the speed at which the FDRSC was infected. For example, 55 systems on the H .0.0 subnet were infected in just over 90 minutes.

> *The most likely interpretation of the backward jump from subnet* G *.0.0 to* F *.0.0 in only 8 minutes is that the infection **actually began earlier** on the* F *.0.0 subnet. Also, that the virus found a target on the* G *.0.0 subnet at Gordon Street & Barkly Street, Footscray (A13) before it found its next candidate system on the* F *0.0 subnet at Nicholson Street & Victoria Parade East Melbourne (C08). This interpretation would also explain why affected systems on the Hume Highway – all of which are* F *.0.0 addresses – were early reported to have been crashing and rebooting.*

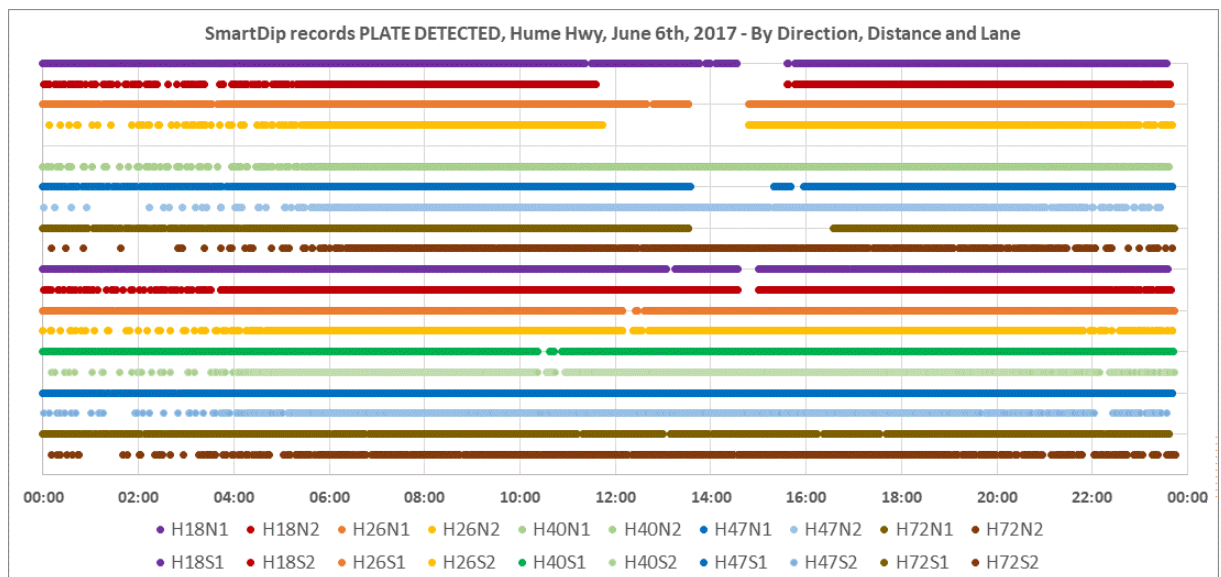
Figure 3 – SmartDip records – Hume Highway – 6 June 2017

97 In Figure 3 each dot represents a minute in which at least one plate was detected and read. From top to bottom the sites are shown first Northbound, then Southbound. H47S2, for example, is Hume Highway, 47 km out, Southbound, Lane 2. H40N1 was not operational on 6 June 2017.

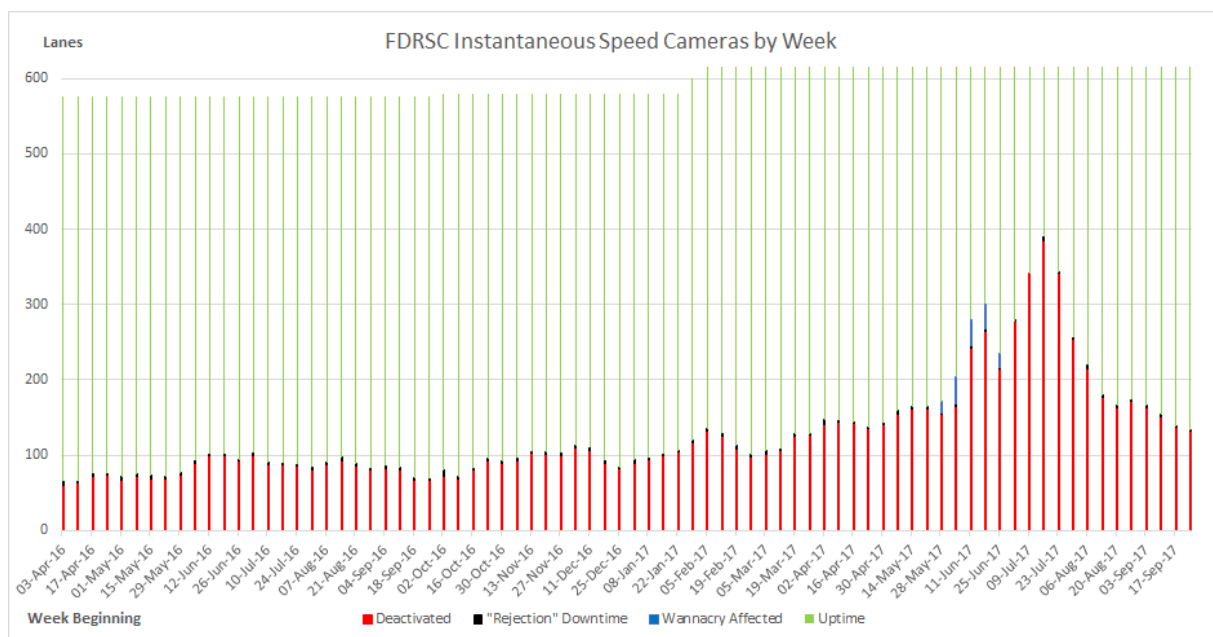
160 Figure 5 shows speed camera uptime and downtime on the FDRSC, by week from 3 April 2016 – 17 September 2017. Vendor 1 provided a breakdown, site-by-site, of downtime minutes experienced by their hardware in the first 28 days of June, 2017. Much, but not all of this downtime, relates to older, affected sites attacked by the virus. For the purpose of this exercise, in circumstances where the precise affected periods are uncertain, downtime for each site has been distributed evenly across the 28 days. If greater detail was available then I would expect higher downtime values in the period 8 June through 19 June. Deactivation periods and Rejection periods often overlap each other. These overlaps have been resolved so as not to "double-count" downtime values. In doing so, priority has been given to Deactivation periods. For example, maintenance time cannot further increase downtime on a system which is already deactivated. Similarly, affected downtime may not be added to a site which is, for example, reporting 100% Deactivation time; downtime on a system that is turned off is meaningless. It follows from the above, the WannaCry Affected values shown are more indicative rather than precise.

162   Figure 5 shows that deactivation downtime increased significantly *after* the period of infection. This was unexpected. A one month "freeze" in camera computer testing and certification resulted in sites' certification lapsing, and the sites classed as "Deactivated" as a result.

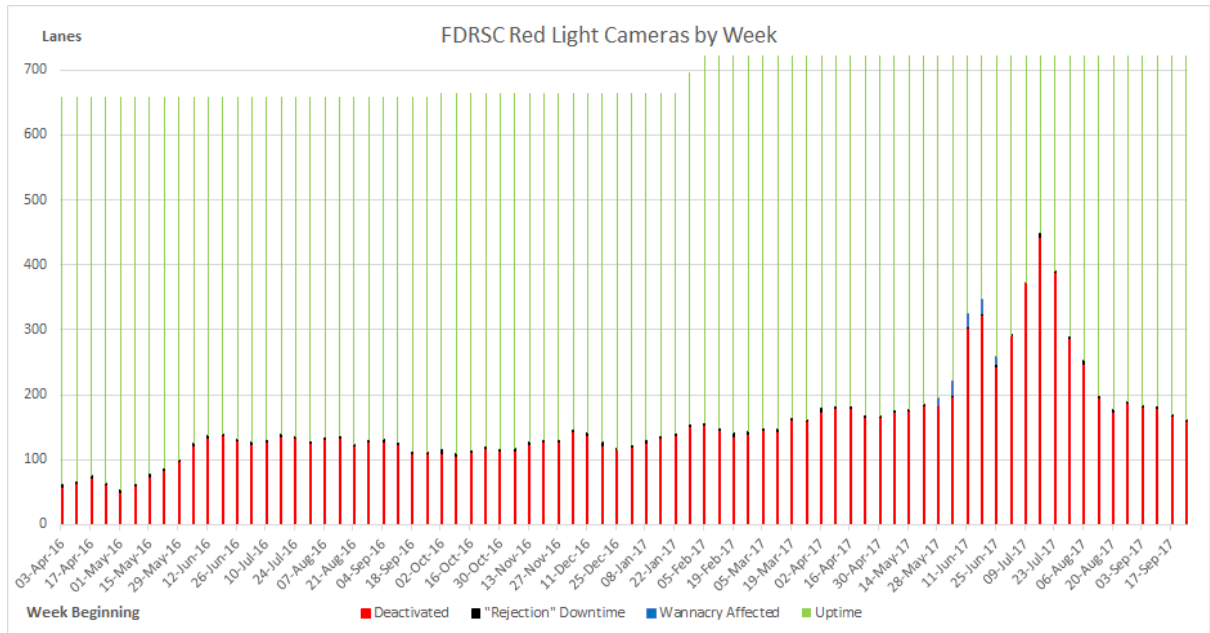
163   Figure 6 is a Red Light camera availability graph. It is similar to Figure 4. However, this is likely because in many instances the same cameras operate both Speed and Red Light detection systems.

- there are overall more Red Light cameras than Speed cameras; and

- more of the Affected systems were highway systems; in particular, Geelong Road, Hume Highway and Peninsula Link.

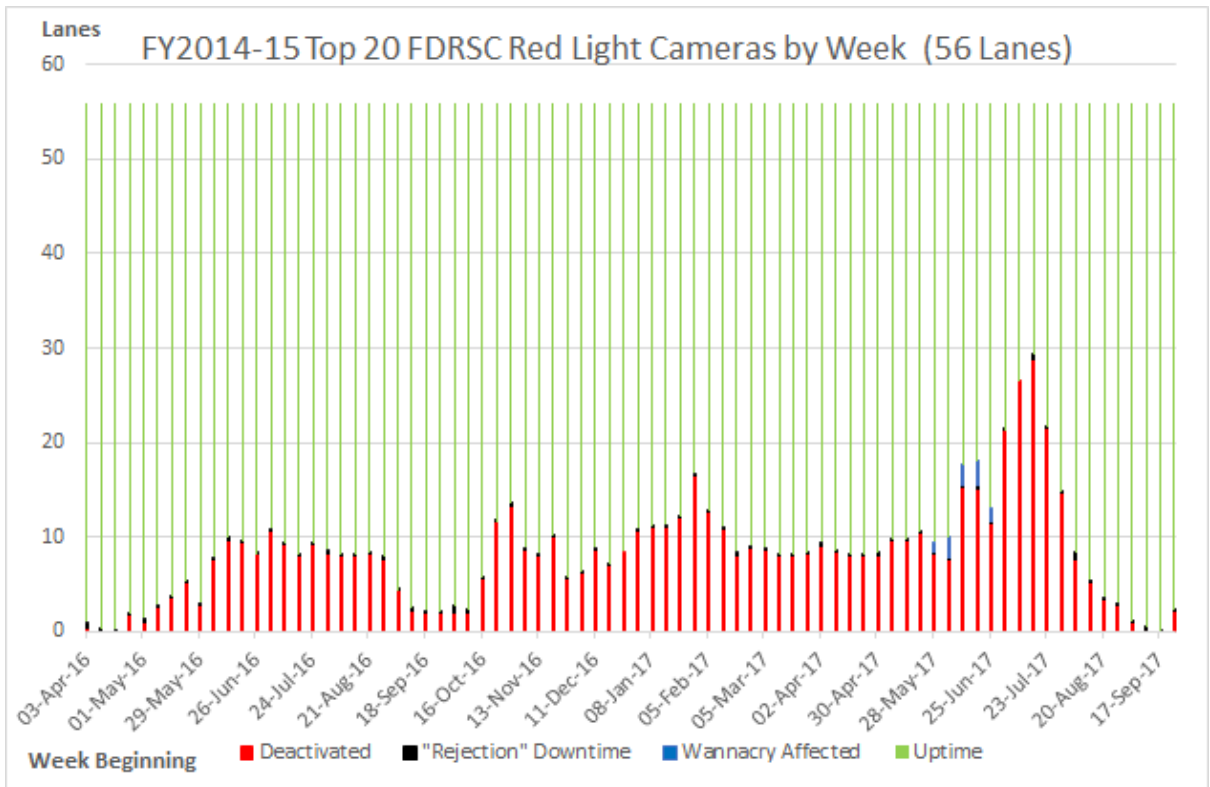
Figure 7-
This figure depicts the downtime activity during the period 27 March 2016 to 24 September 2017 of the top 20 fixed digital red light road safety cameras (of the 2014-15 financial year).

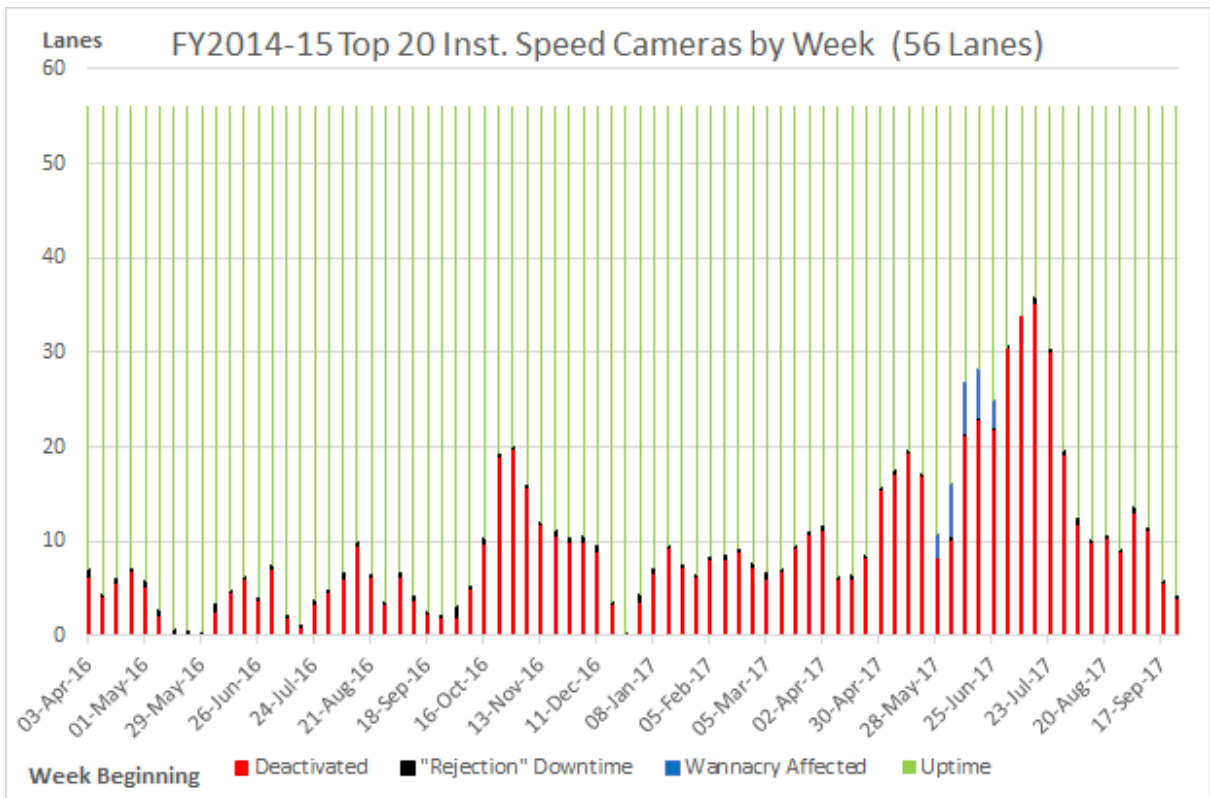
Figure 8
This figure depicts the downtime activity during the period 27 March 2016 to 24 September 2017 of the top 20 fixed digital instantaneous road safety cameras (of the 2014-15 financial year).
