REPORT OF THE ROAD SAFETY CAMERA COMMISSIONER TO THE MINISTER FOR POLICE

Investigation into four fixed road safety cameras operating in 40km/h speed limit zones

Release date: 23 July 2015

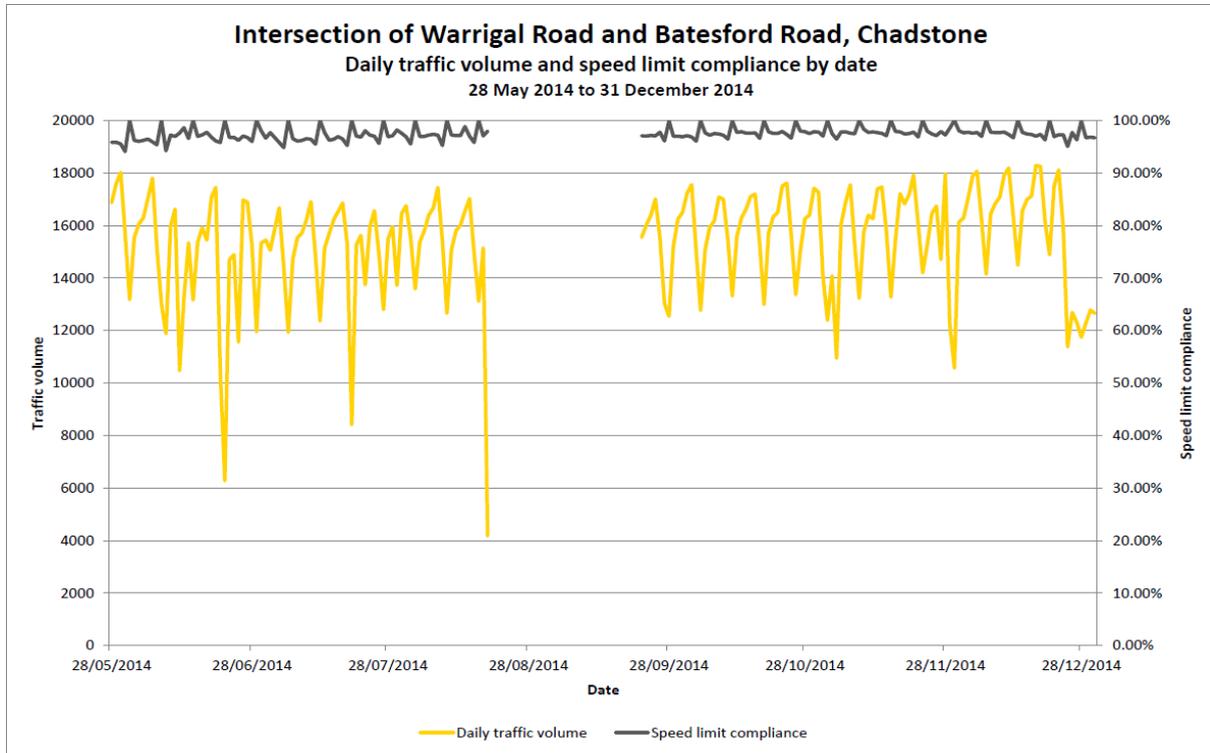
These diagrams show that the weekly traffic volume pattern remains relatively consistent, with a peak in traffic volume from winter to just before Christmas, before falling away dramatically. The data also shows a downward trend in the number of vehicles detected exceeding the speed limit throughout this period. It must be noted that due to the nature of the variable speed limit along Warrigal Road, very few speed incidents were recorded on Sundays, as can be seen in **Figure C1.2**.

Figure C1.1 – Daily traffic volume recorded at the intersection of Warrigal Road and Batesford Road, Chadstone.

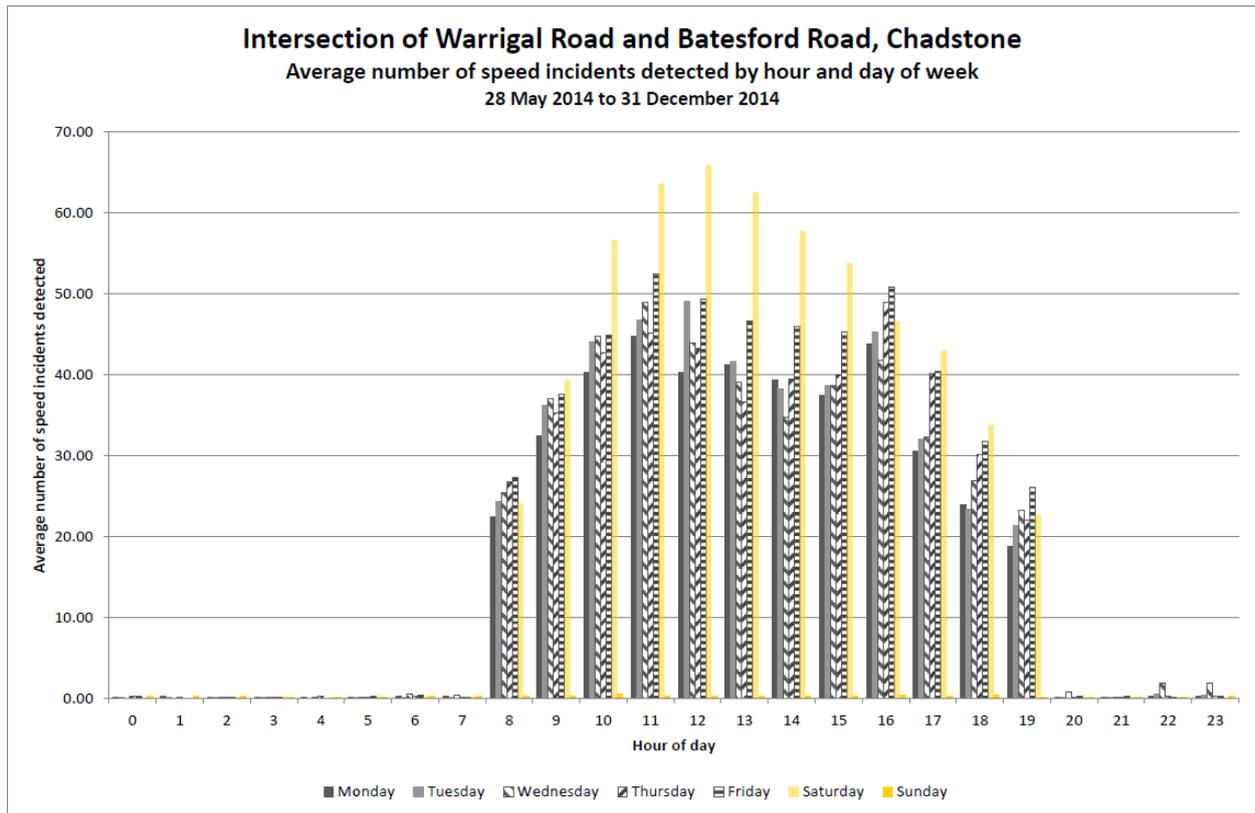
Figure C1.3 – Average number of speed incidents recorded at the intersection of Warrigal Road and Batesford Road, Chadstone, by hour of day, and day of week.

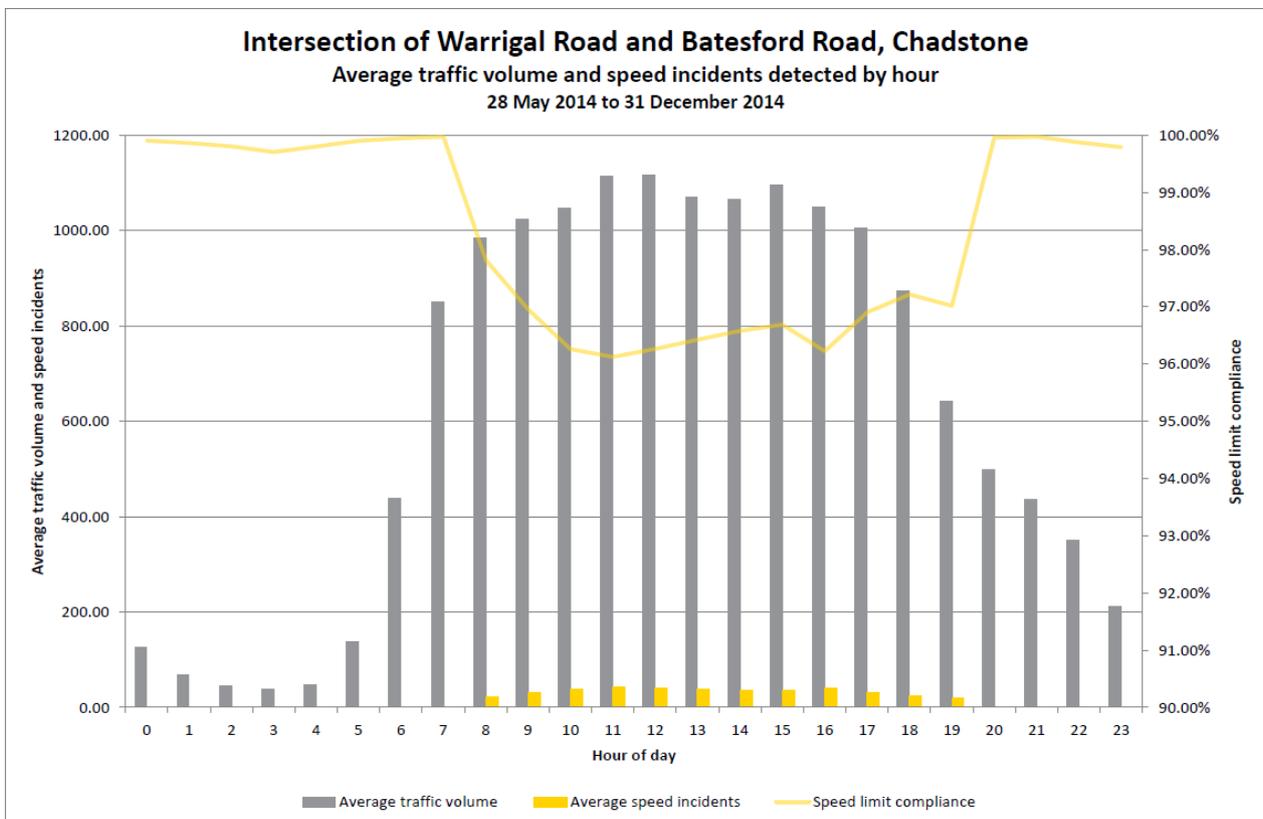
Figure C1.4 – Average traffic volume and number of speed incidents recorded at the intersection of Warrigal Road and Batesford Road, Chadstone, by hour of day.

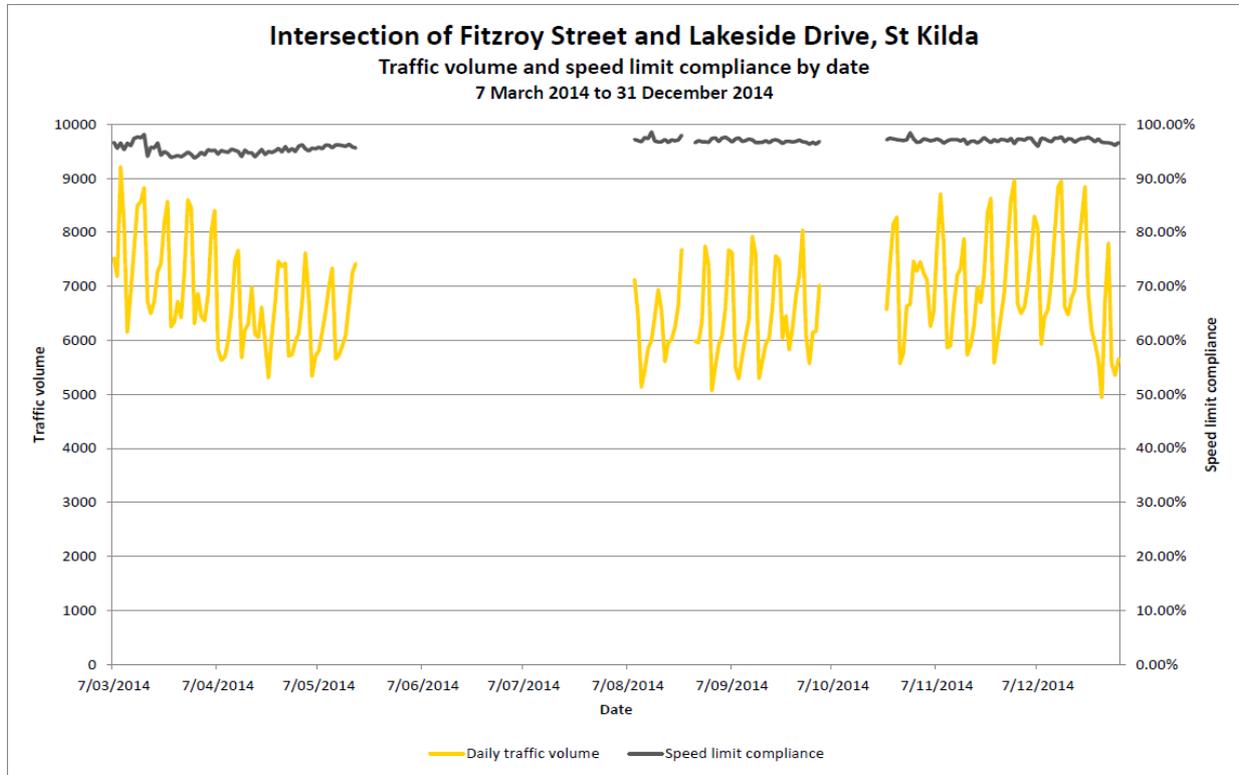
Figure C2.1 – Daily traffic volume recorded at the intersection of Fitzroy Street and Lakeside Drive, St Kilda.

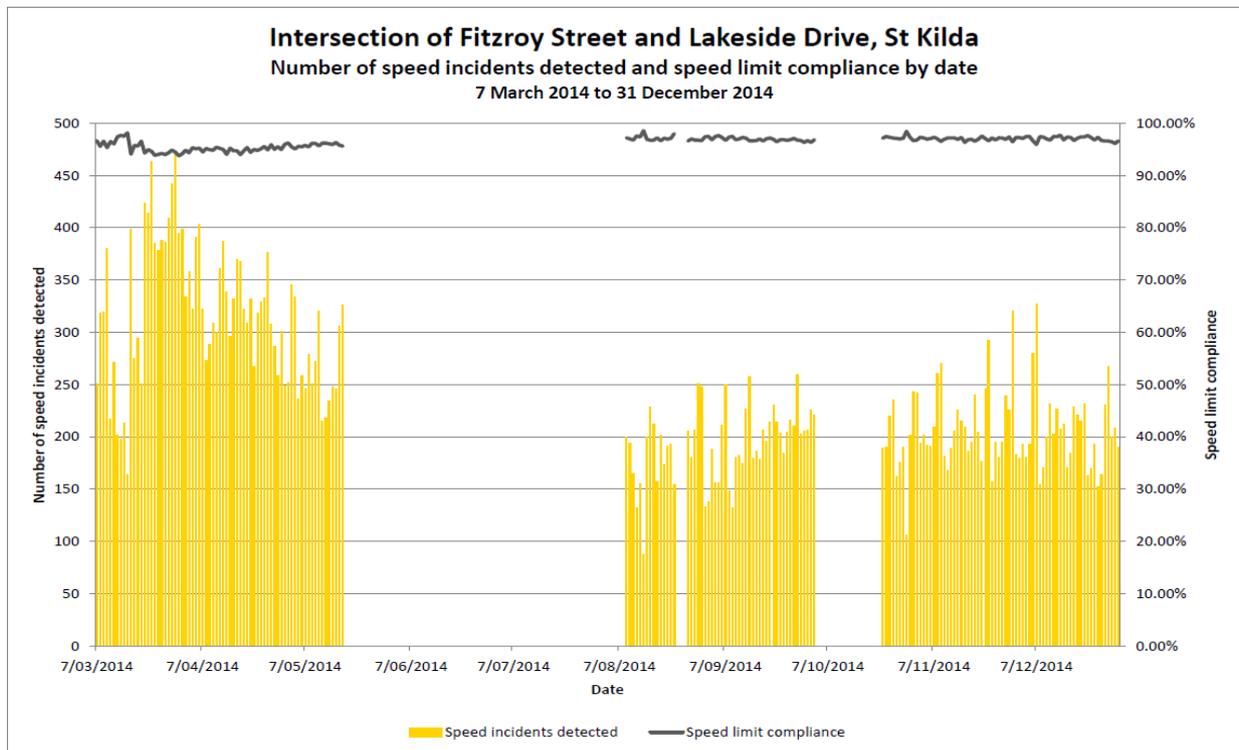
Figure C2.2 – Number of speed incidents detected at the intersection of Fitzroy Street and Lakeside Drive, St Kilda.

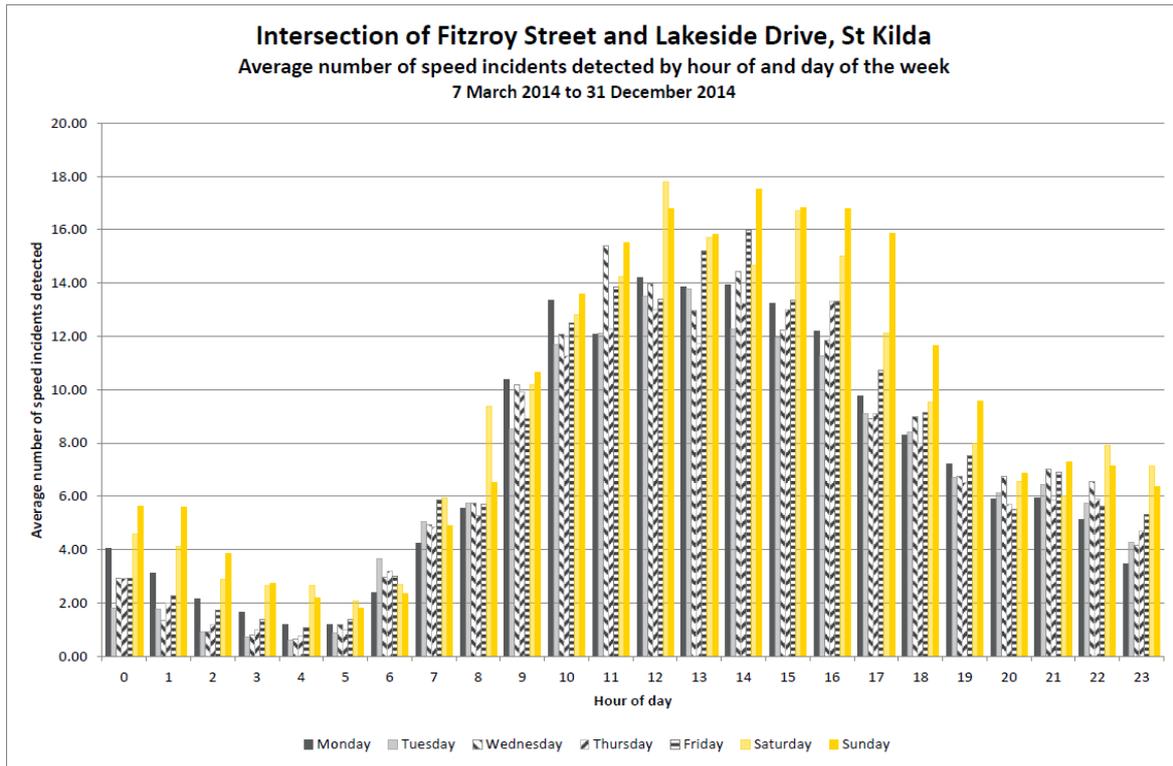
Figure C2.3 – Average number of speed incidents recorded at the intersection of Fitzroy Street and Lakeside Drive, St Kilda, by hour of day, and day of week.

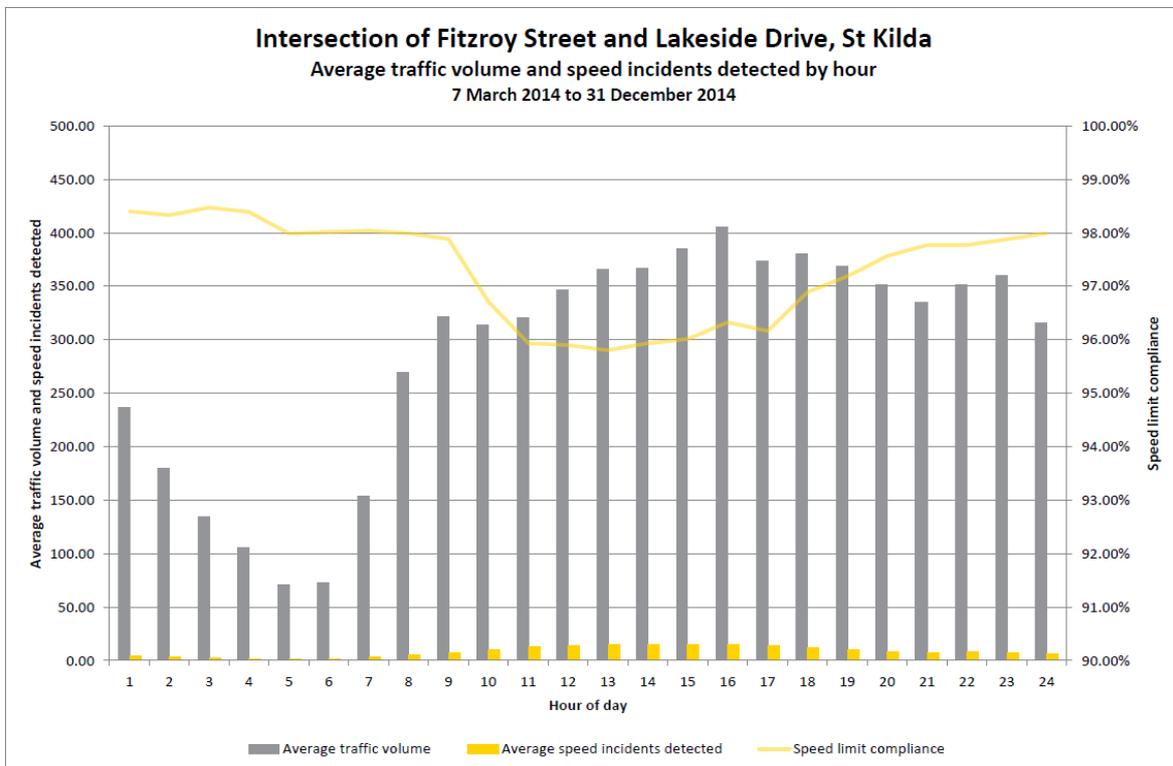
Figure C2.4 – Average traffic volume and number of speed incidents recorded at the intersection of Fitzroy Street and Lakeside Drive, St Kilda, by hour of day.

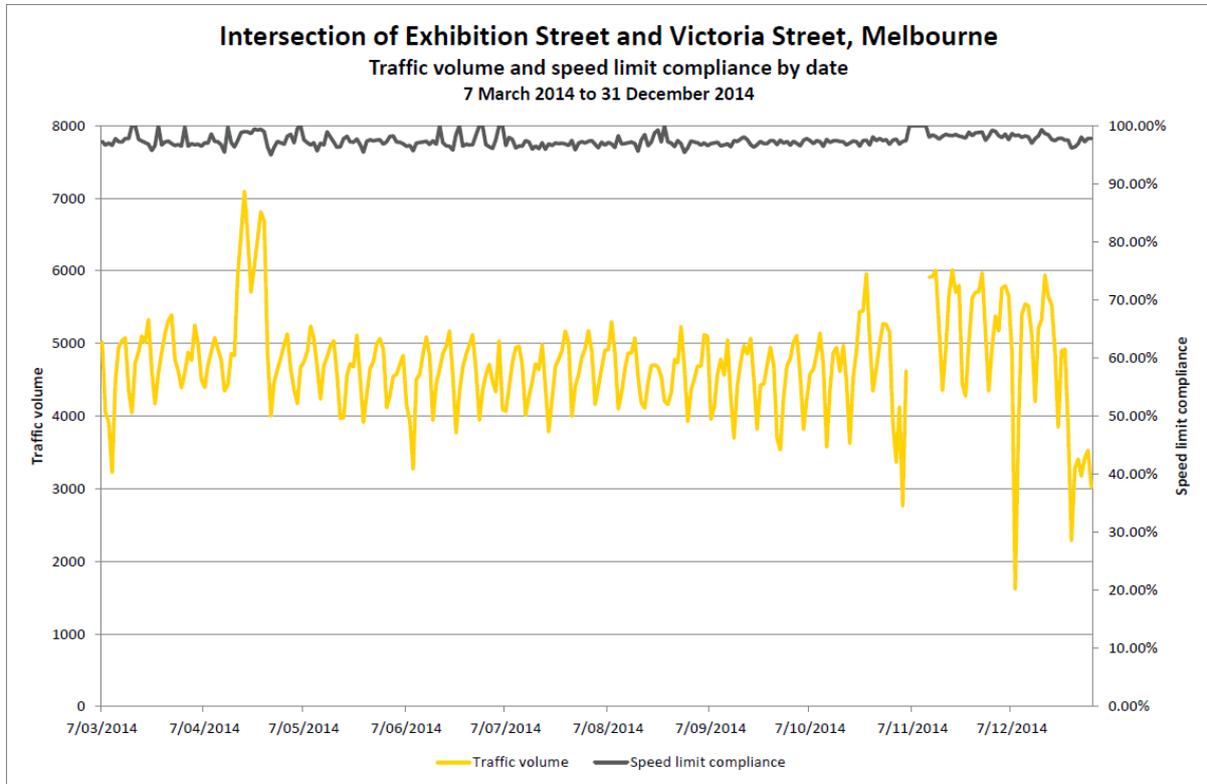
Figure C3.1 – Traffic volume recorded at the intersection of Exhibition Street and Victoria Street, Melbourne.

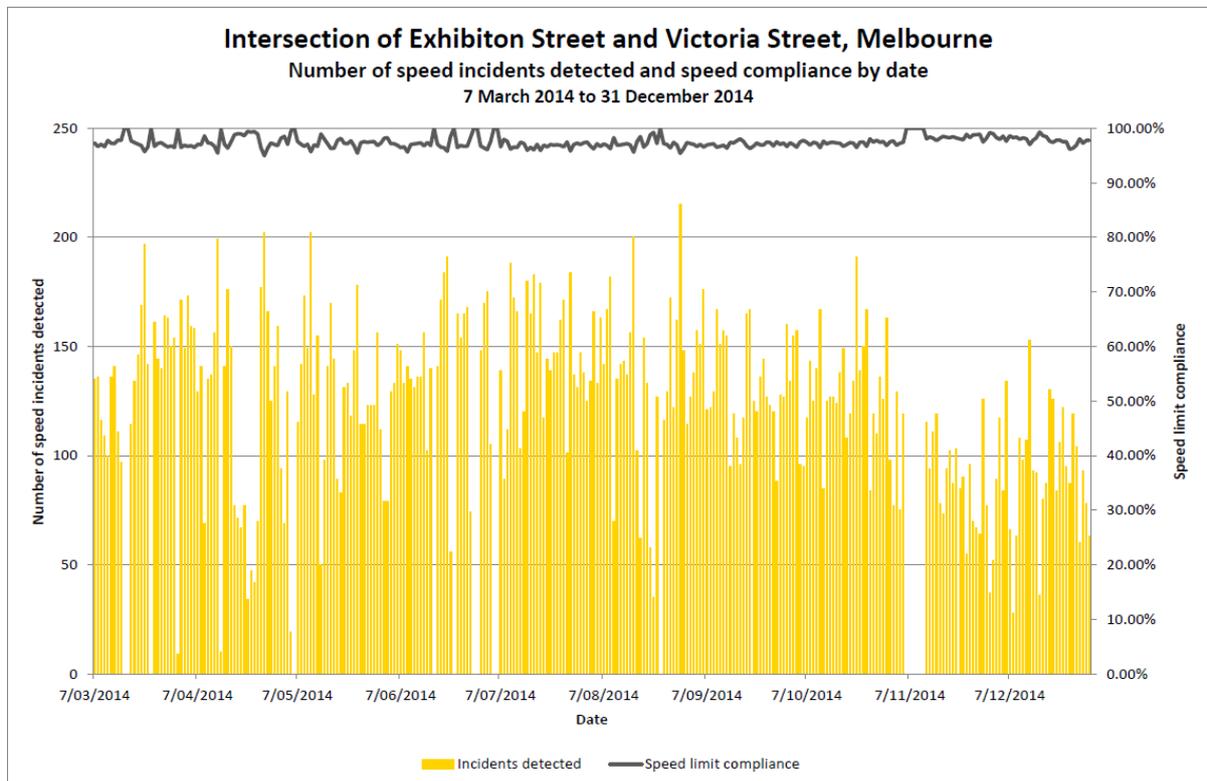
Figure C3.2 – Number of speed incidents detected at the intersection of Exhibition Street and Victoria Street, Melbourne.

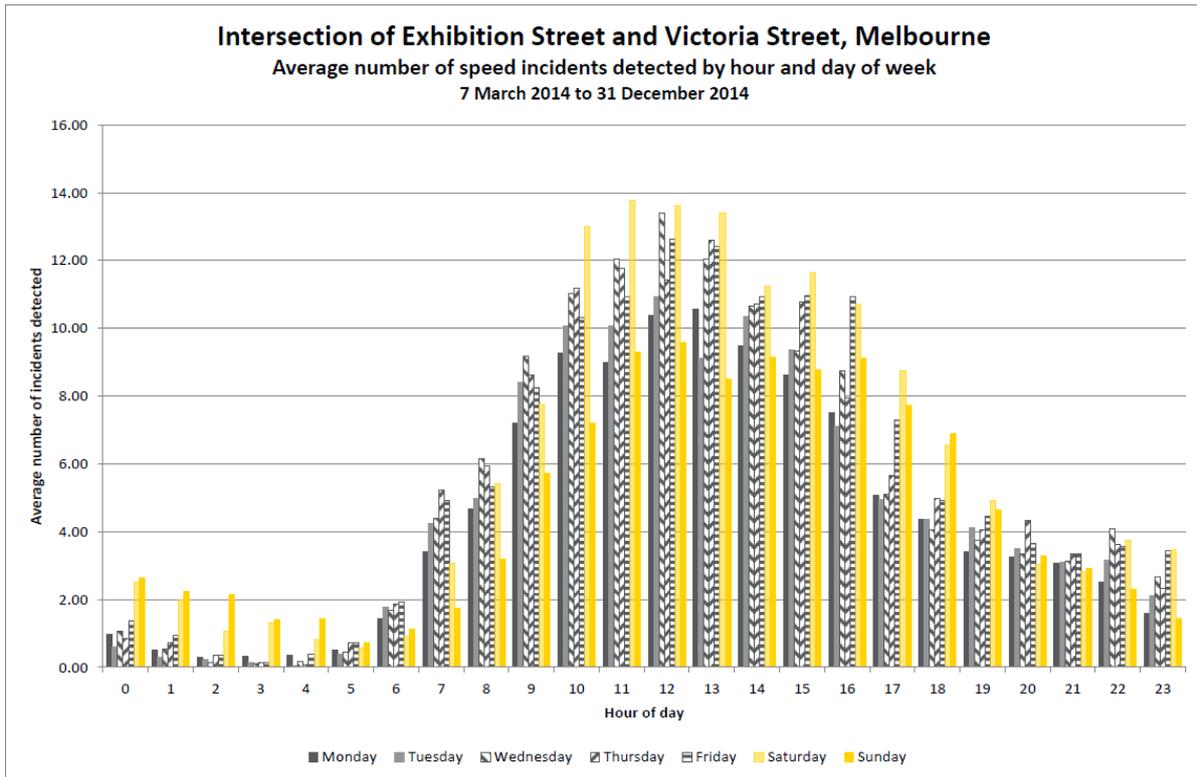
Figure C3.3 – Average number of speed incidents recorded at the intersection of Exhibition Street and Victoria Street, Melbourne, by hour of day, and day of week.

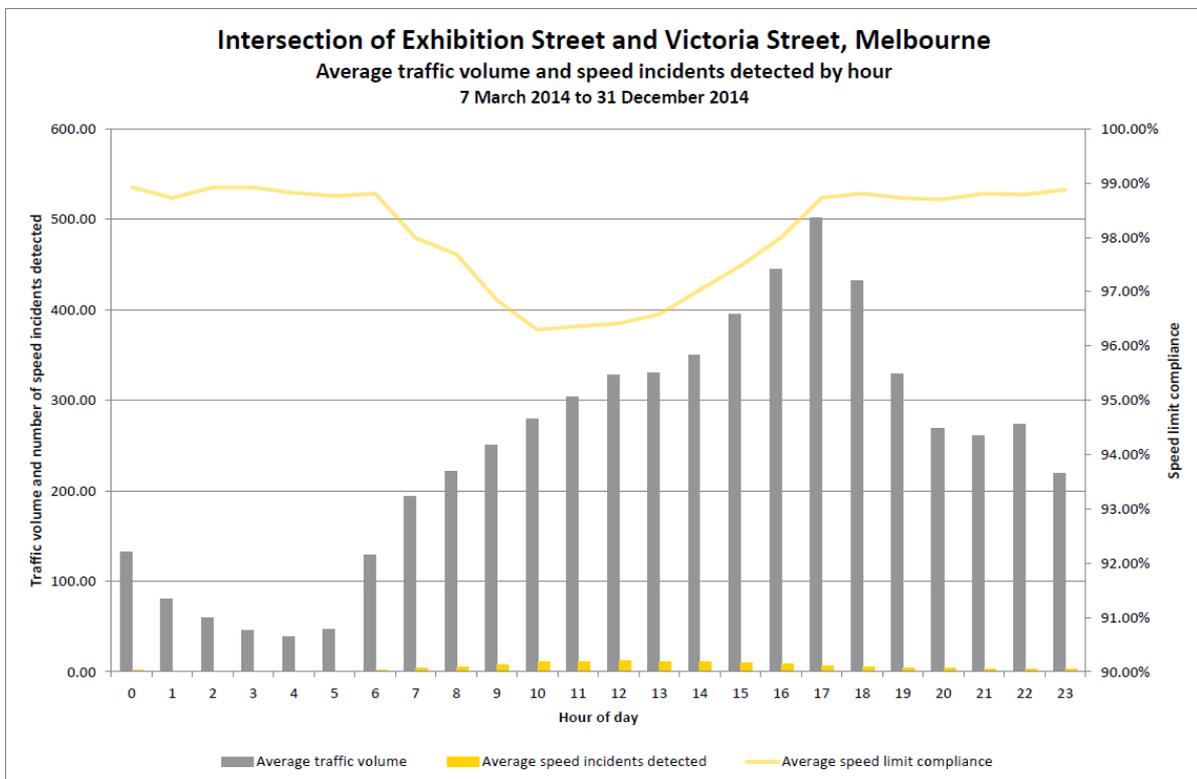
Figure C3.4 – Average traffic volume and number of speed incidents recorded at the intersection of Exhibition Street and Victoria Street, Melbourne, by hour of day.

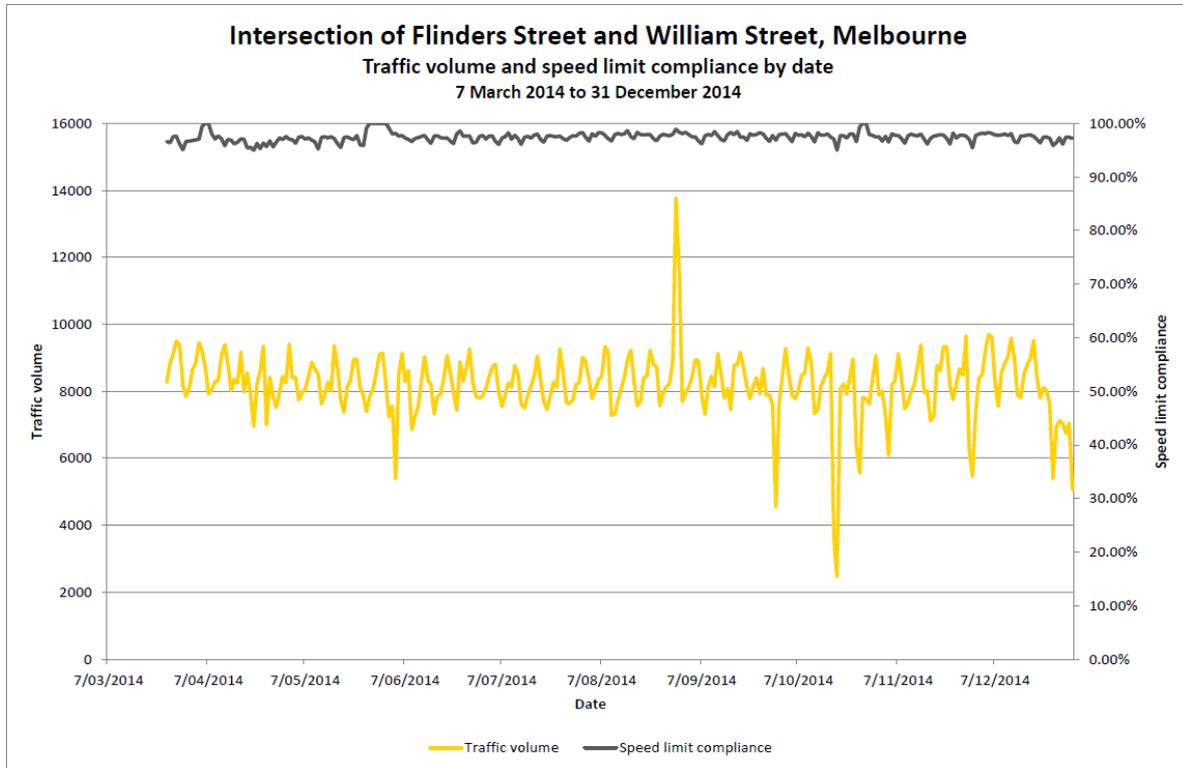
Figure C4.1 – Traffic volume recorded at the intersection of Flinders Street and William Street, Melbourne.

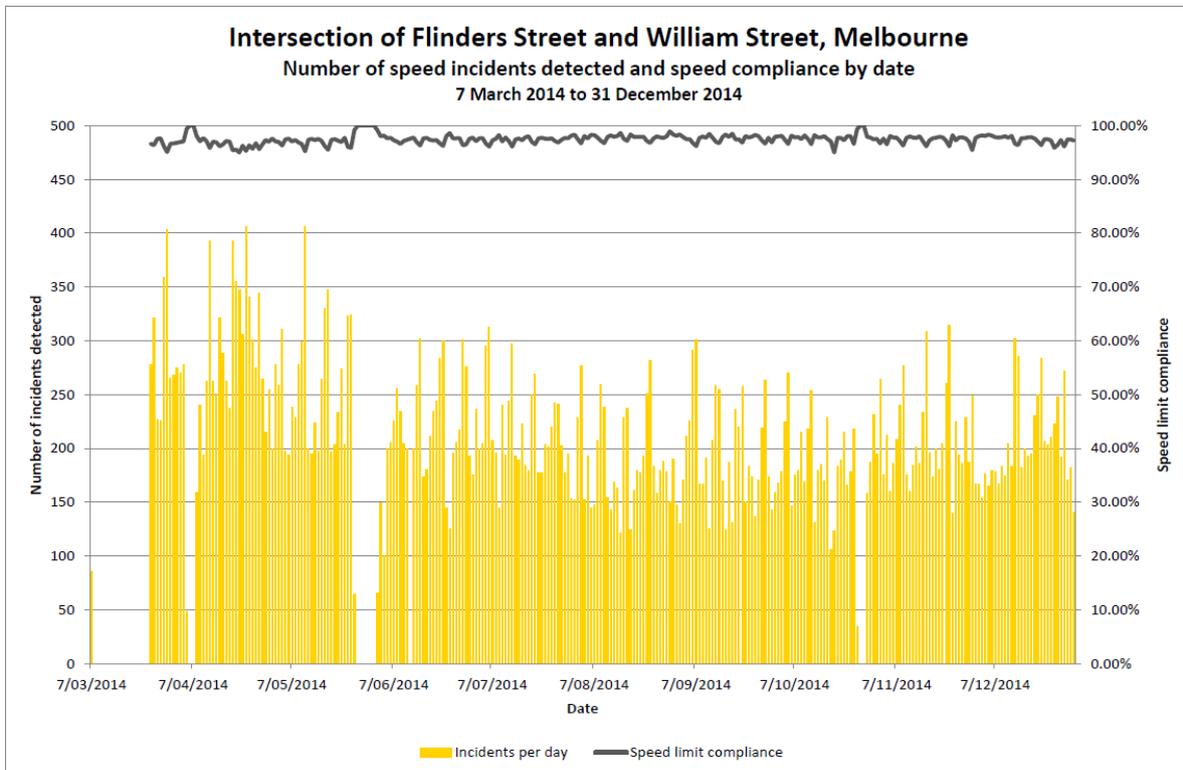
Figure C4.2 – Number of speed incidents detected at the intersection of Flinders Street and William Street, Melbourne.

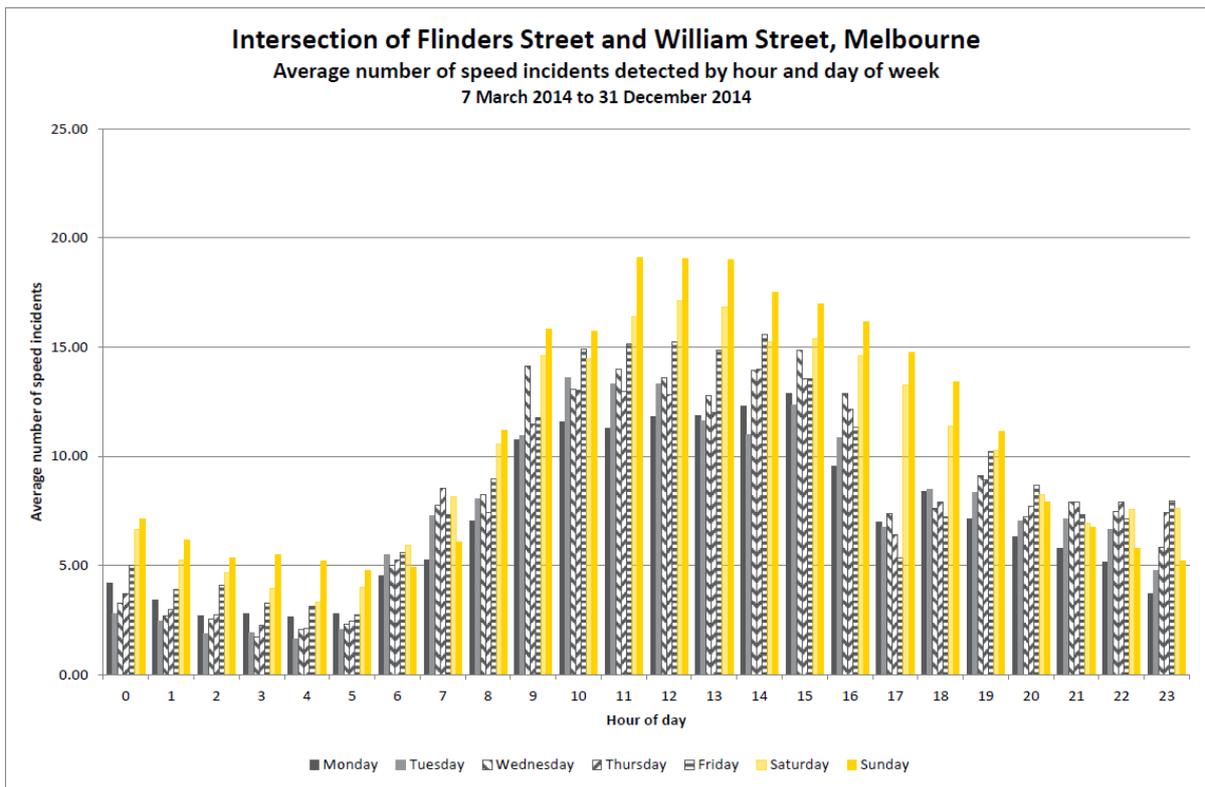
Figure C4.3 – Average number of speed incidents recorded at the intersection of Flinders Street and William Street, Melbourne, by hour of day, and day of week.

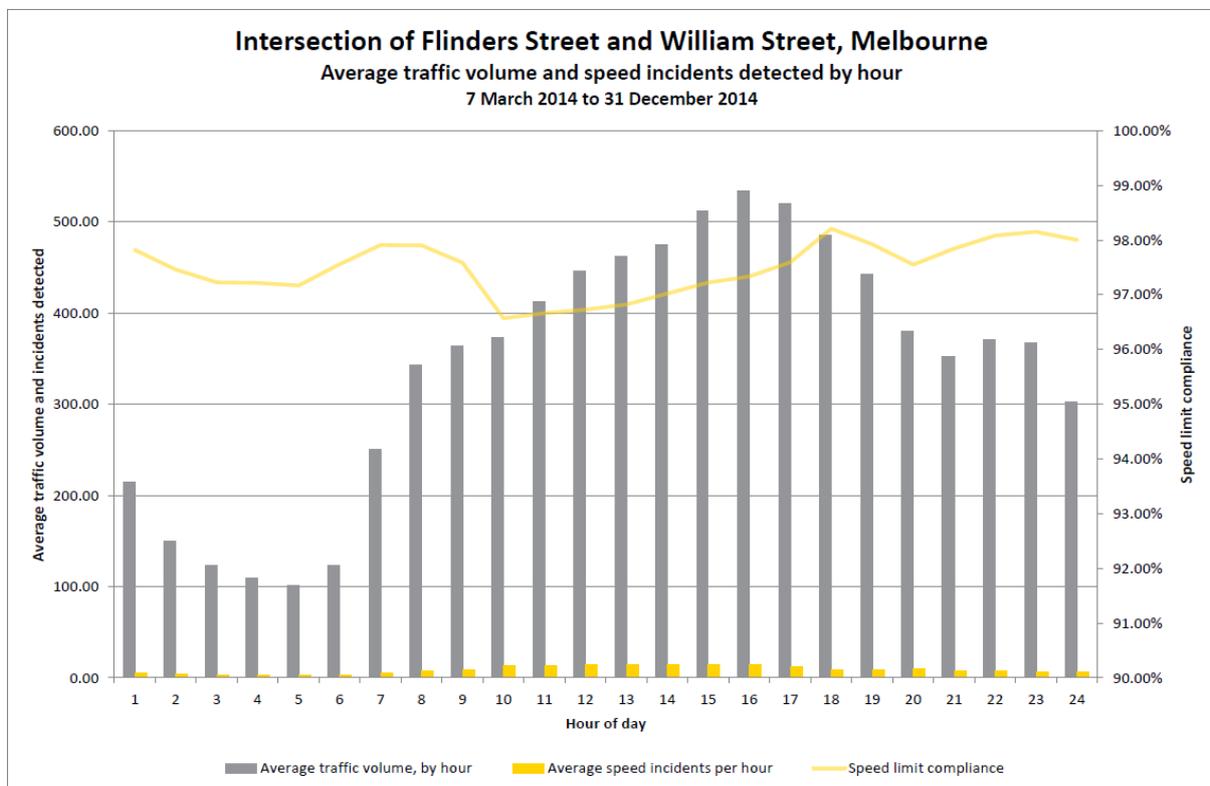
Figure C4.4 – Average traffic volume and number of speed incidents recorded at the intersection of Flinders Street and William Street, Melbourne, by hour of day.

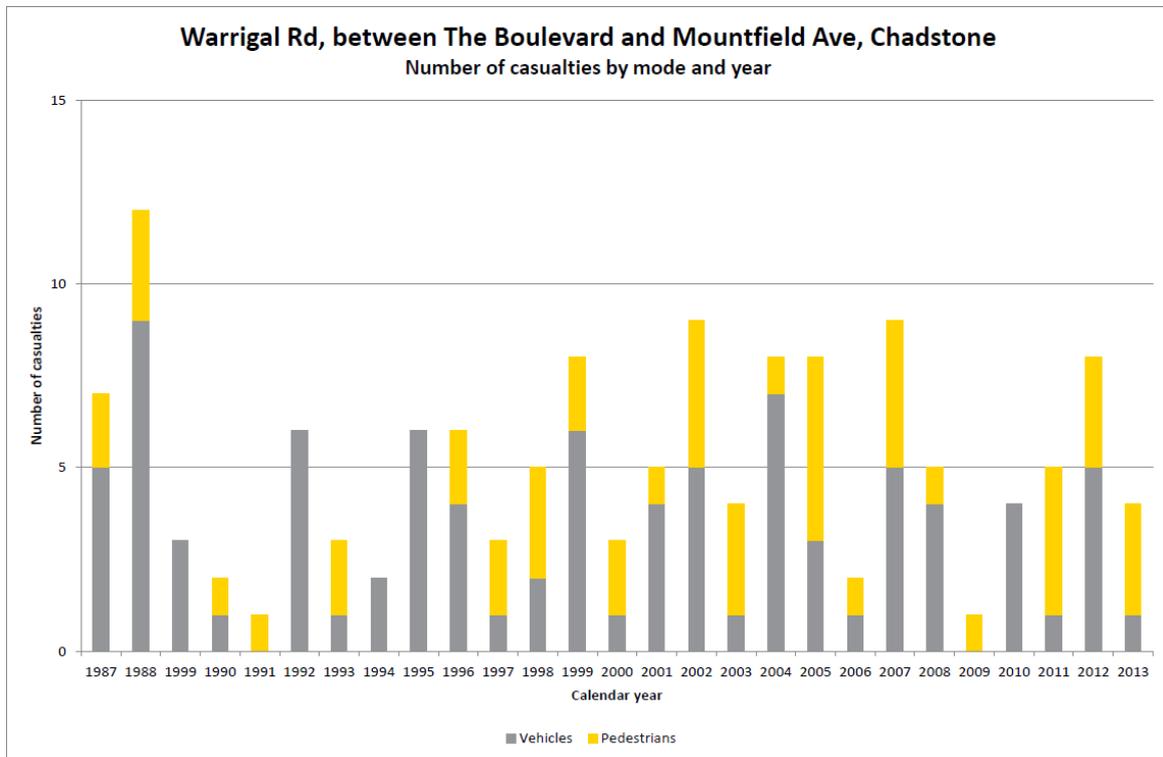
Figure D1 – Number of casualties recorded along Warrigal Road, between The Boulevard and Mountford Avenue, Chadstone from 1 January 1987 to 31 December 2013

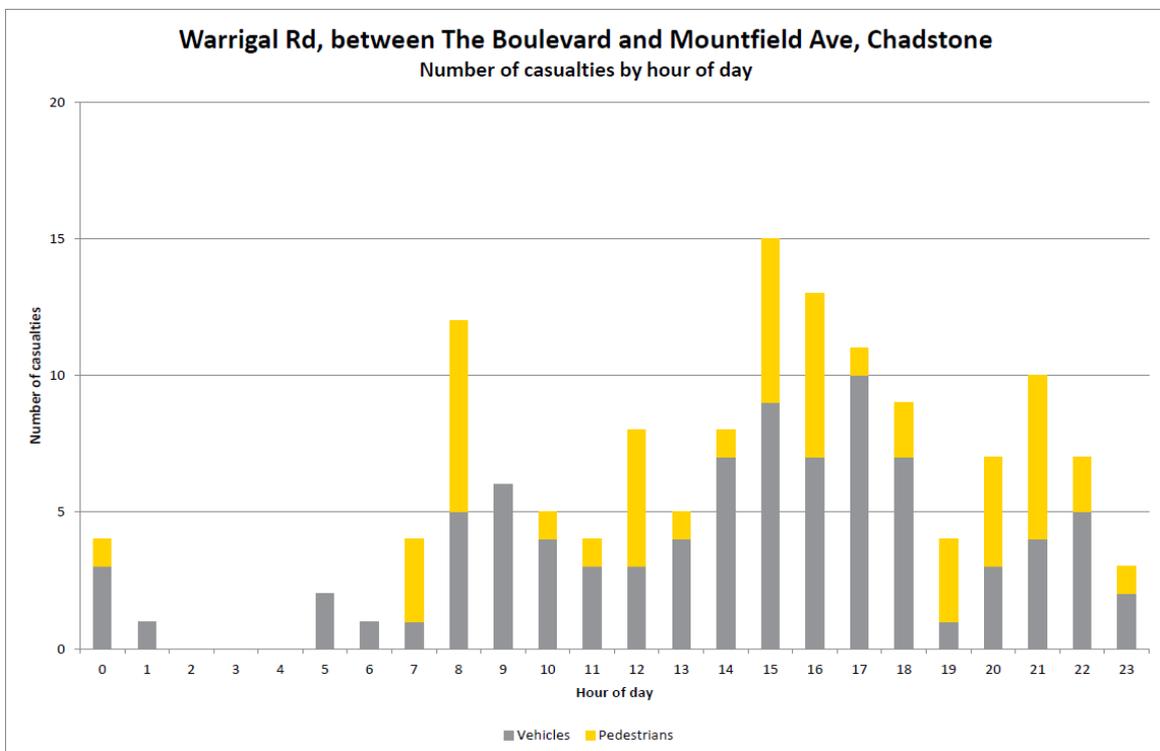
Figure D2 – Number of casualties by hour of day along Warrigal Road, between The Boulevard and Mountford Avenue, Chadstone from 1 January 1987 to 31 December 2013

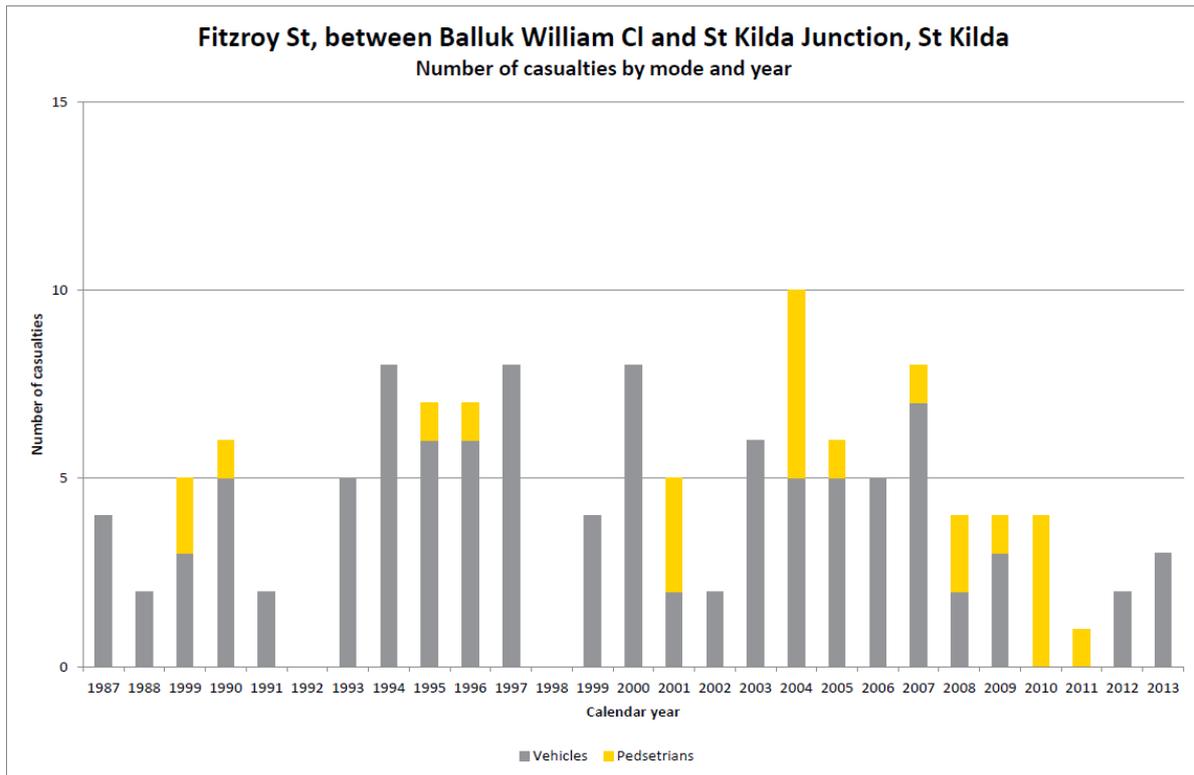
Figure D3 – Number of casualties recorded along Fitzroy Street, between Balluk William Close and St Kilda Junction, St Kilda from 1 January 1987 to 31 December 2013

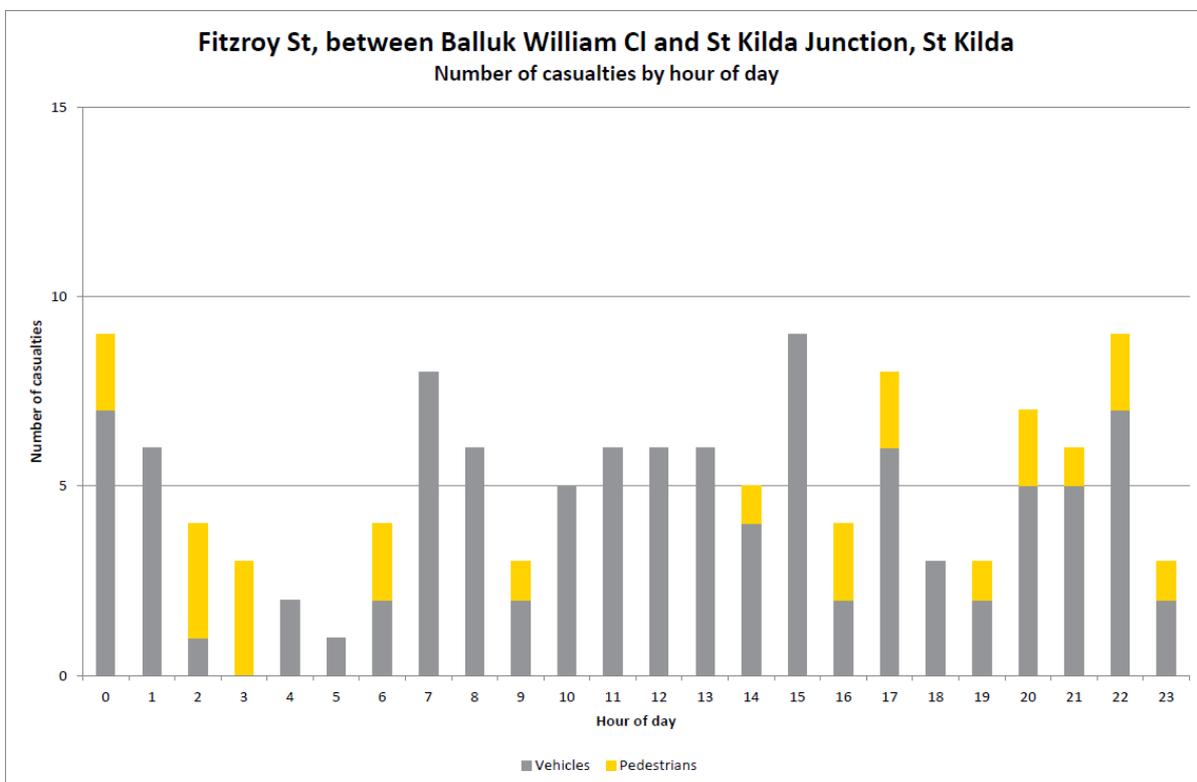
Figure D4 – Number of casualties by hour of day along Fitzroy Street, between Balluk William Close and St Kilda Junction, St Kilda from 1 January 1987 to 31 December 2013

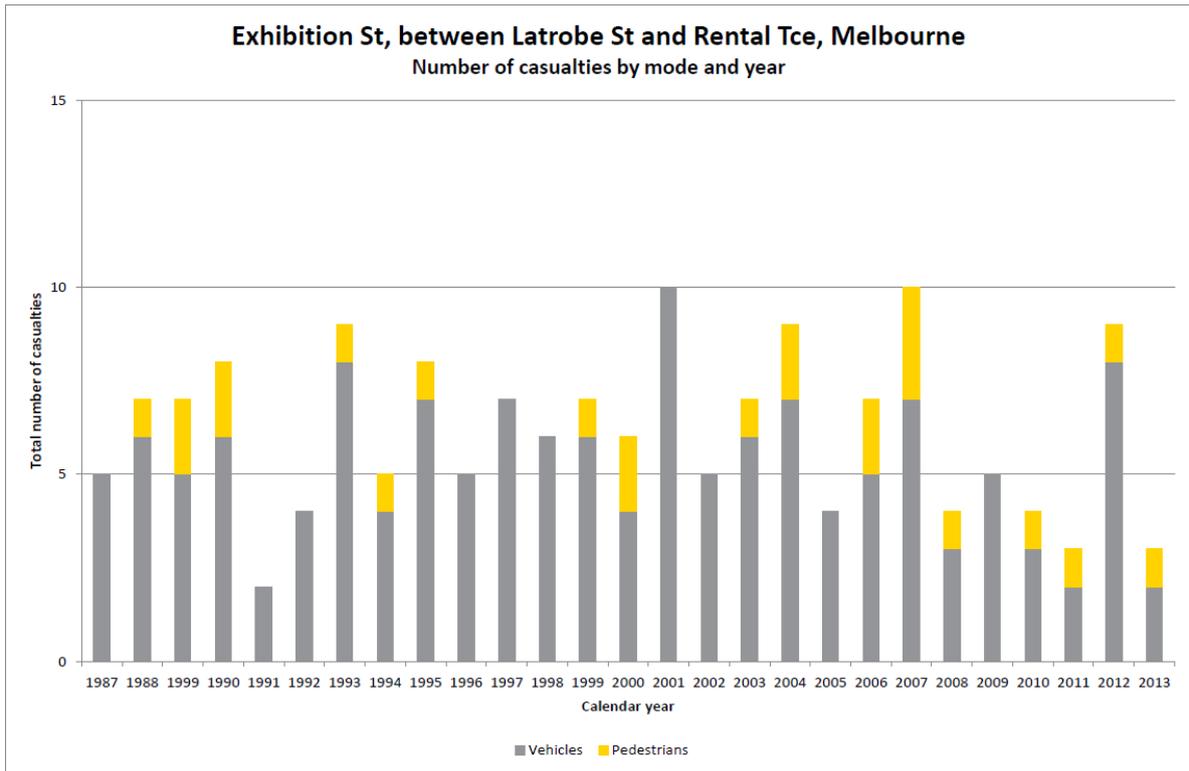
Figure D5 – Number of casualties recorded along Exhibition Street, between Latrobe Street and Rental Terrace, Melbourne from 1 January 1987 to 31 December 2013

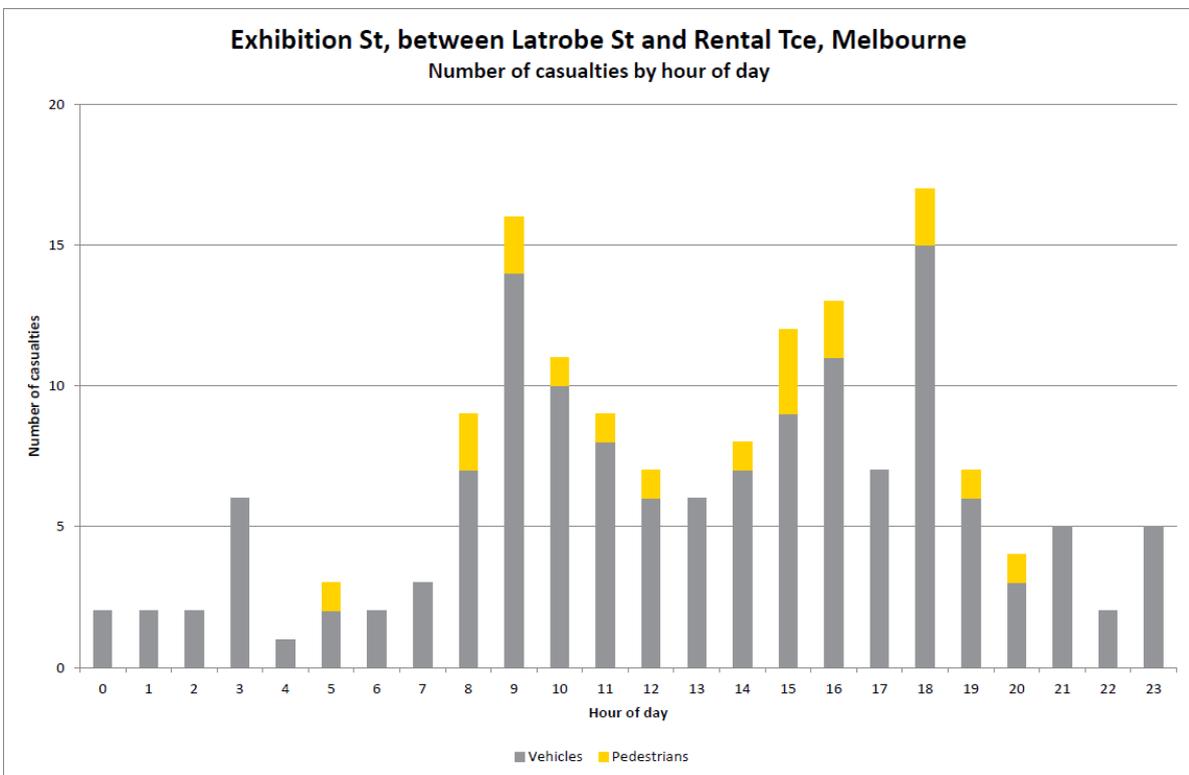
Figure D6 – Number of casualties by hour of day along Exhibition Street, between Latrobe Street and Rental Terrace, Melbourne from 1 January 1987 to 31 December 2013

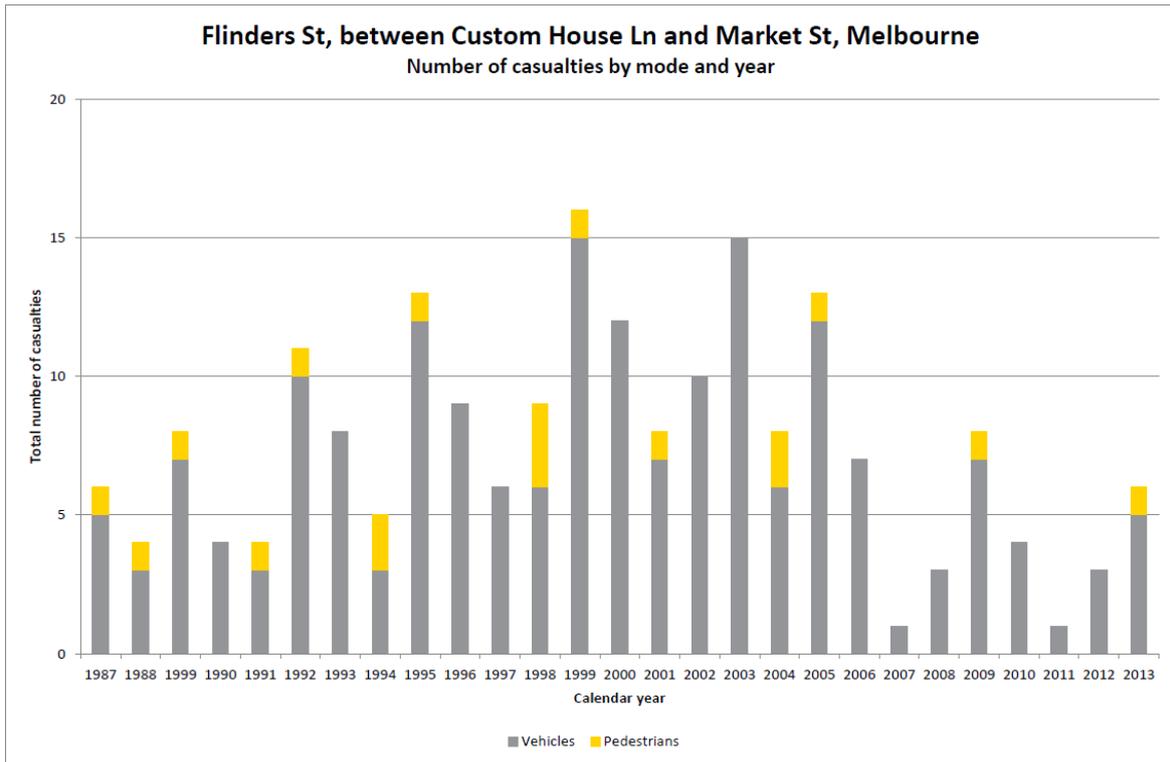
Figure D7 – Number of casualties recorded along Flinders Street, between Custom House Lane and Market Street, Melbourne from 1 January 1987 to 31 December 2013

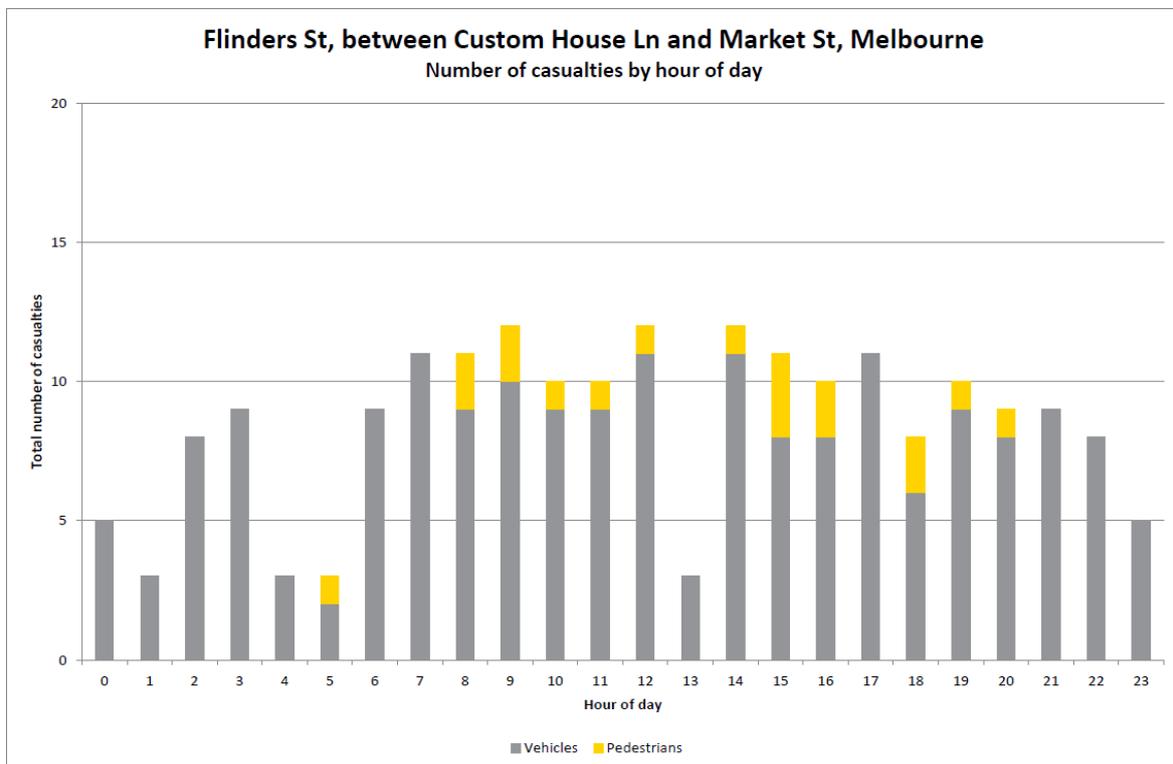
Figure D8 – Number of casualties by hour of day along Flinders Street, between Custom House Lane and Market Street, Melbourne from 1 January 1987 to 31 December 2013
