**Road Safety
Camera
Commissioner**

**REPORT TO THE MINISTER FOR
POLICE ON THE ROAD SAFETY
CAMERAS AT LODERS RD BRIDGE,
PENINSULA LINK**

04 October 2018

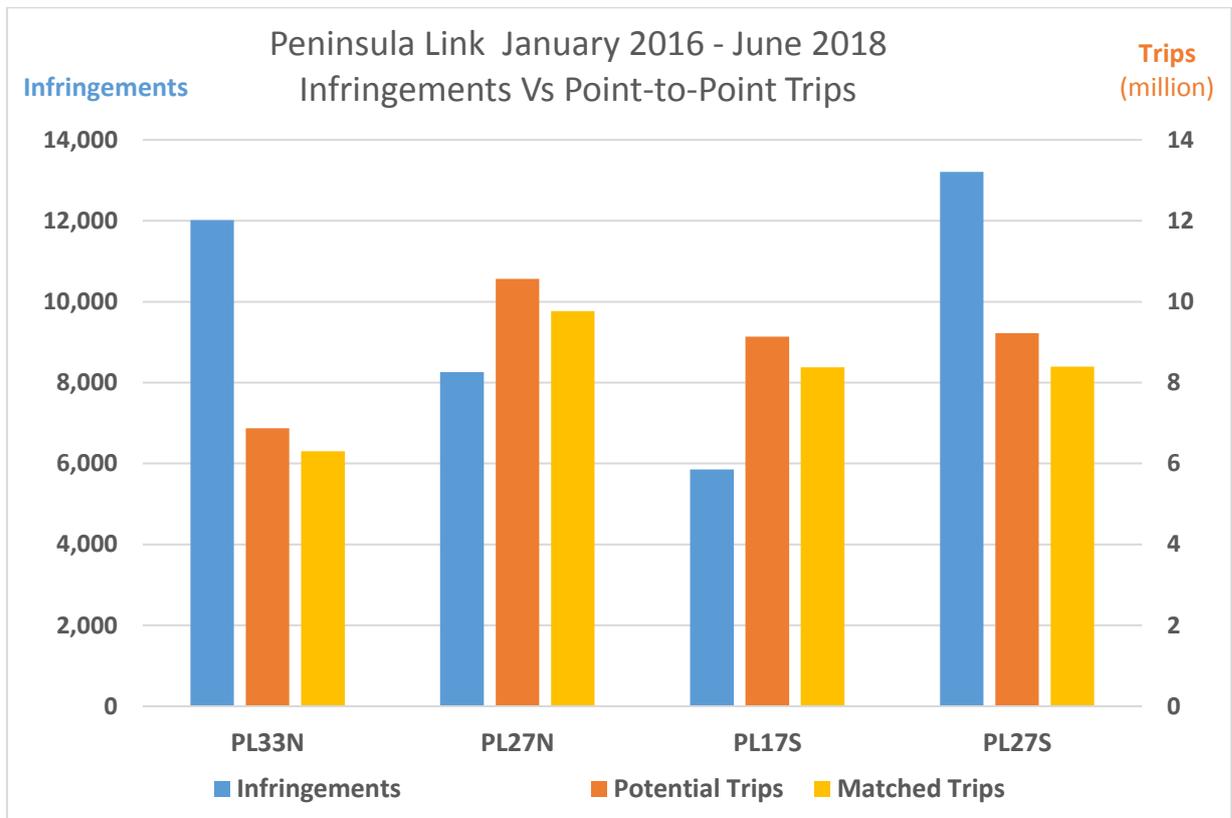
Figure 3

- 19 While it appears from the above graphs that PL33N is 'overrepresented' in infringement numbers, particularly in instantaneous infringements, it is worth noting that PL33N generated zero infringements in eleven of the thirty months considered. If infringements in that eleven month period had occurred at the same rate then PL33N's infringement numbers might have been more than 40% higher than as shown.
