REPORT OF THE ROAD SAFETY CAMERA COMMISSIONER TO THE MINISTER FOR POLICE AND CORRECTIONS

Investigation into the fixed road safety cameras at the Maroondah Highway pedestrian crossing in Lilydale, approximately 100 metres west of Hutchinson Street

Investigation into the road safety cameras on Maroondah Highway, Lilydale, approximately 100 metres west of Hutchinson Street

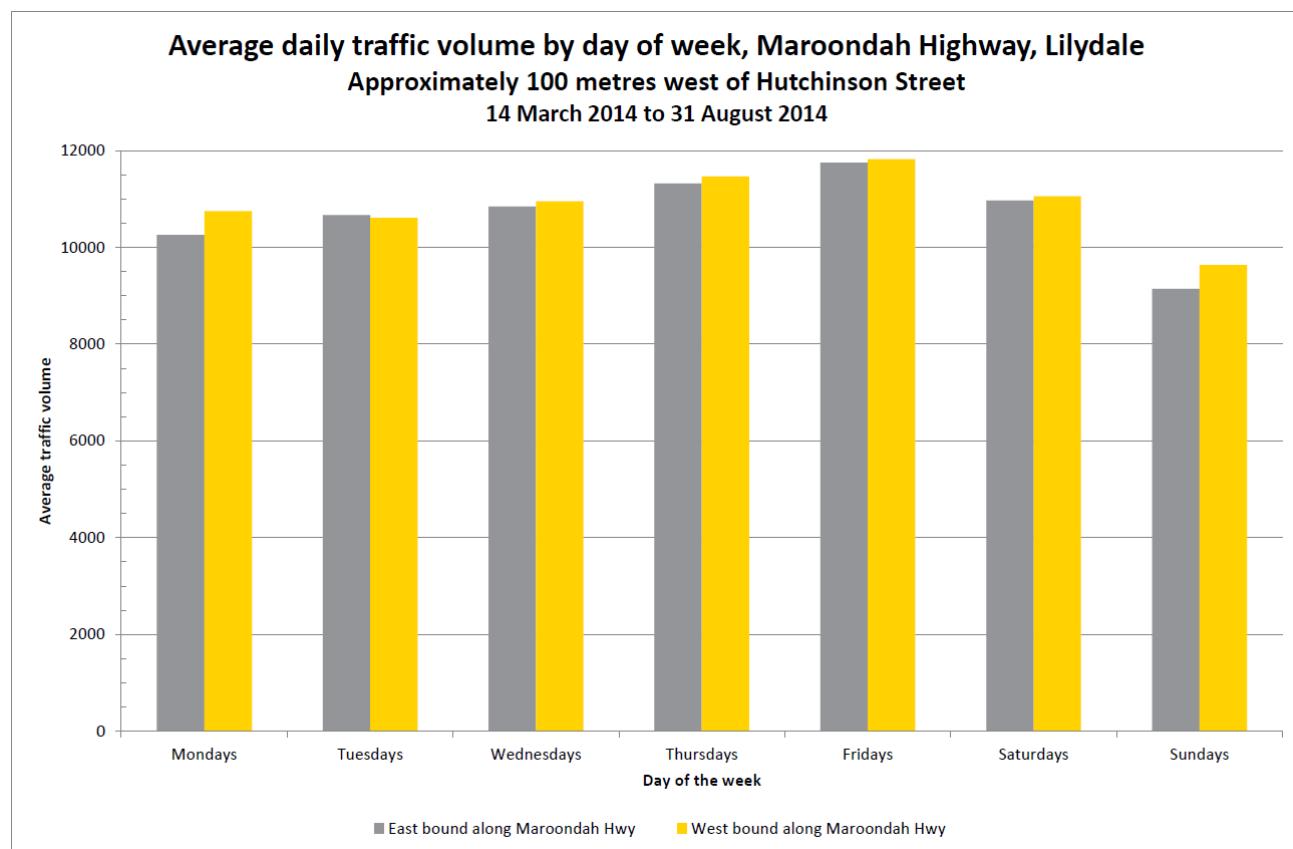
Figure 1 – Average traffic volume by day of week in each direction along Maroondah Highway in Lilydale.

- 38 In its analysis of traffic behaviour along Maroondah Highway in Lilydale, my office examined the movement of 3,694,239 vehicles. The number of vehicles travelling in each direction, depicted in **Figure 1**, were:
- 1,830,713, 49.56% of the total, in an easterly direction along Maroondah Highway, and
 - 1,863,526, 50.44% of the total, in a westerly direction along Maroondah Highway.

- 39 The slight difference in traffic volume may be due to motorists accessing shops located along the adjacent service lanes, bypassing the cameras on their way home in an easterly direction.
- 40 Typically, the left lanes in each direction of travel carried most of the traffic volume. **Table 1** shows the distribution of traffic volume through the lanes along Maroondah Highway in Lilydale.

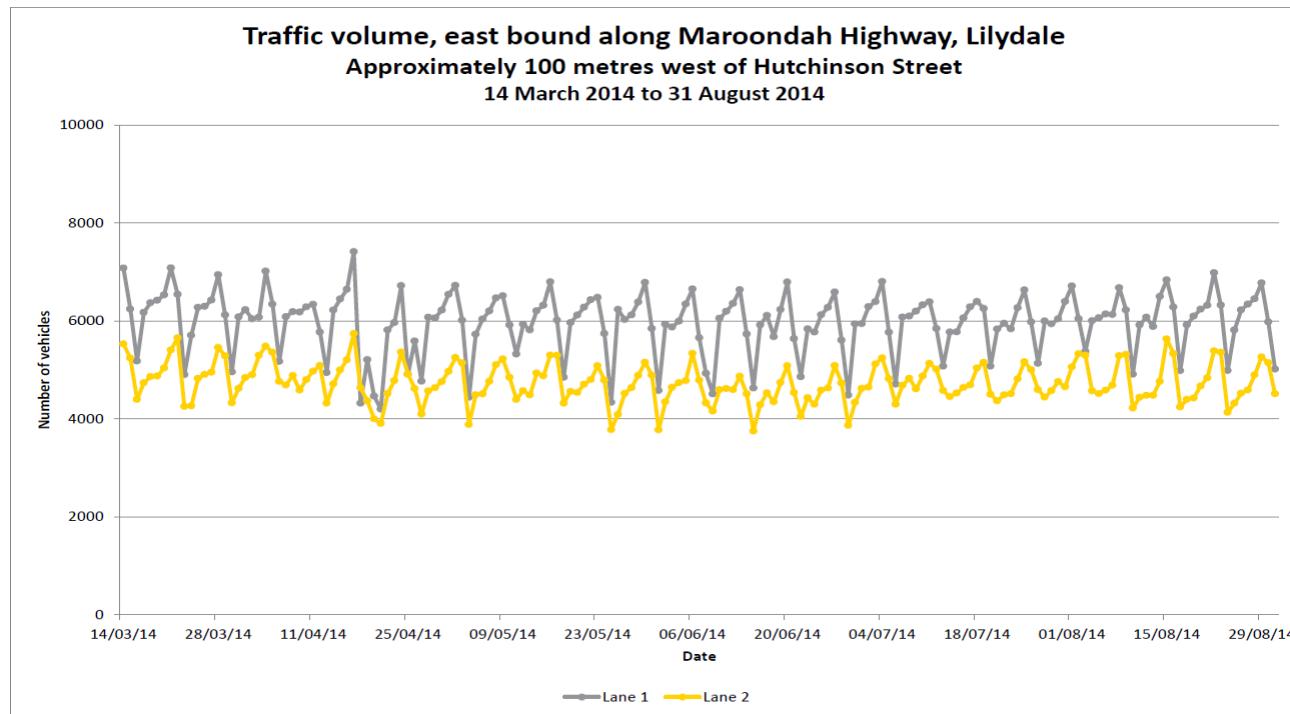
Figure C1 – Daily traffic volume of vehicles travelling east along Maroondah High, Lilydale

- 41** Also typical, are the daily traffic volume totals, which increase from Mondays to Fridays with a drop in traffic during the weekends. The hourly traffic volumes in each direction follow a defined pattern of peak hour travel in the mornings and afternoons, with a high level of local traffic throughout the day. Overall, Sundays have the lowest typical traffic volume over the week. More detailed traffic volume graphs are contained in **Appendix C** of this report.
- 42** Note that, between 24 June 2014 to 10 July 2014 inclusive, the left lane in the west bound direction of the pedestrian crossing was not operating due to maintenance. This meant that no traffic or incident data was recorded during this period.

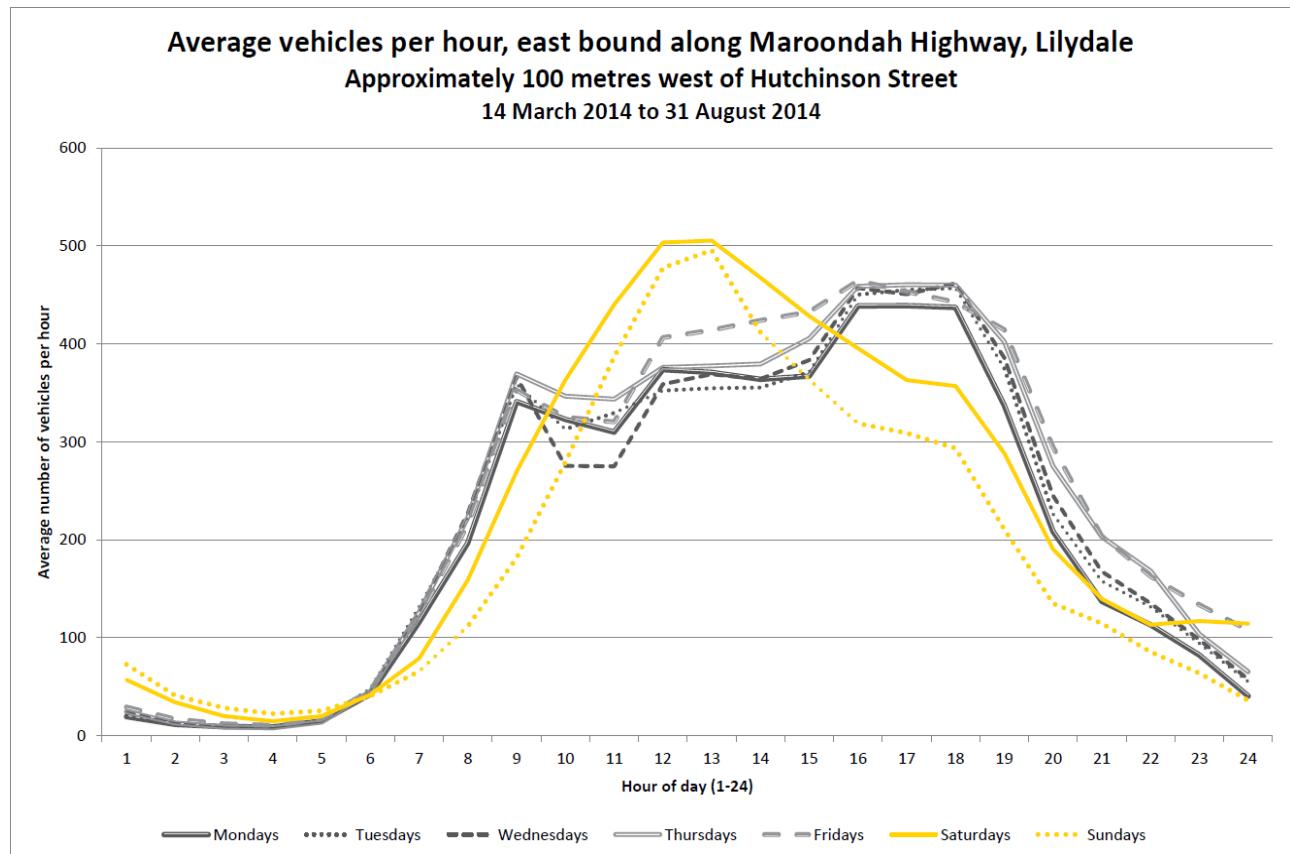
Figure C2 – Average hourly volume of vehicles travelling east along Maroondah High, Lilydale

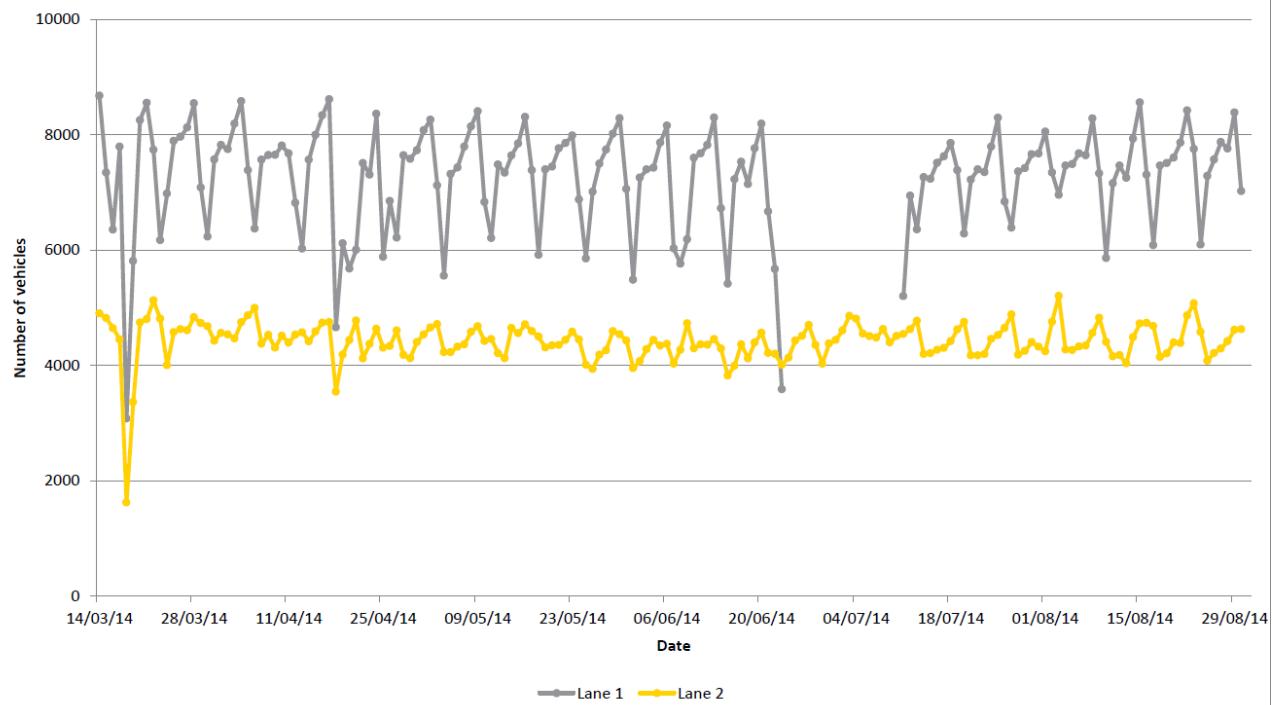
Figure C3 – Daily traffic volume of vehicles travelling west along Maroondah High, Lilydale

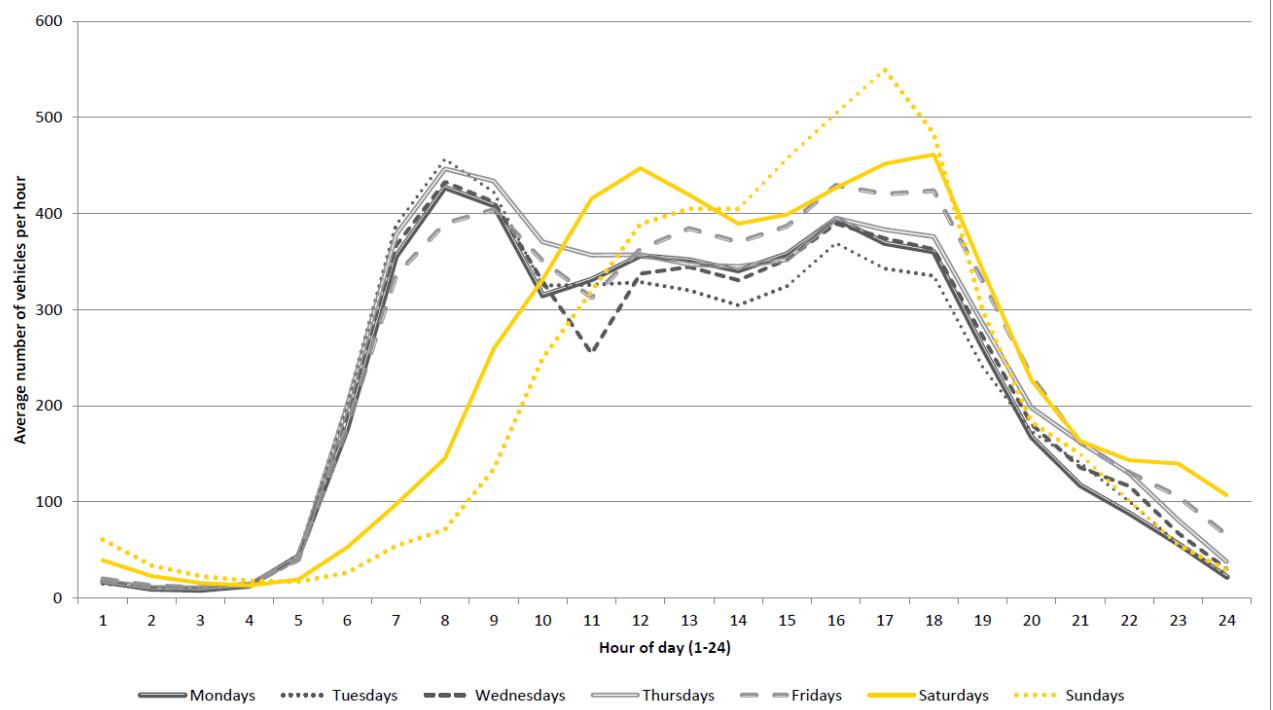
Average vehicles per hour, west bound along Maroondah Highway, Lilydale

Figure C4 – Average hourly volume of vehicles travelling west along Maroondah High, Lilydale

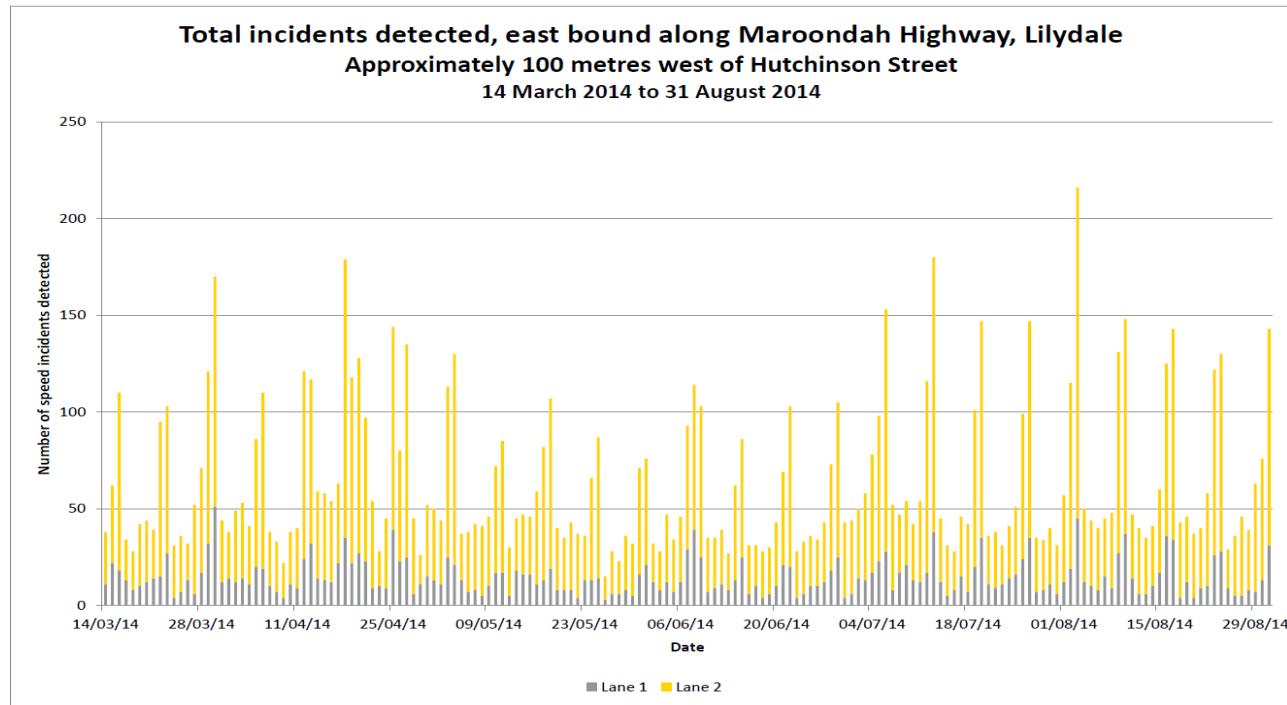
Figure D1 – Daily incidents detected travelling east along Maroondah High, Lilydale

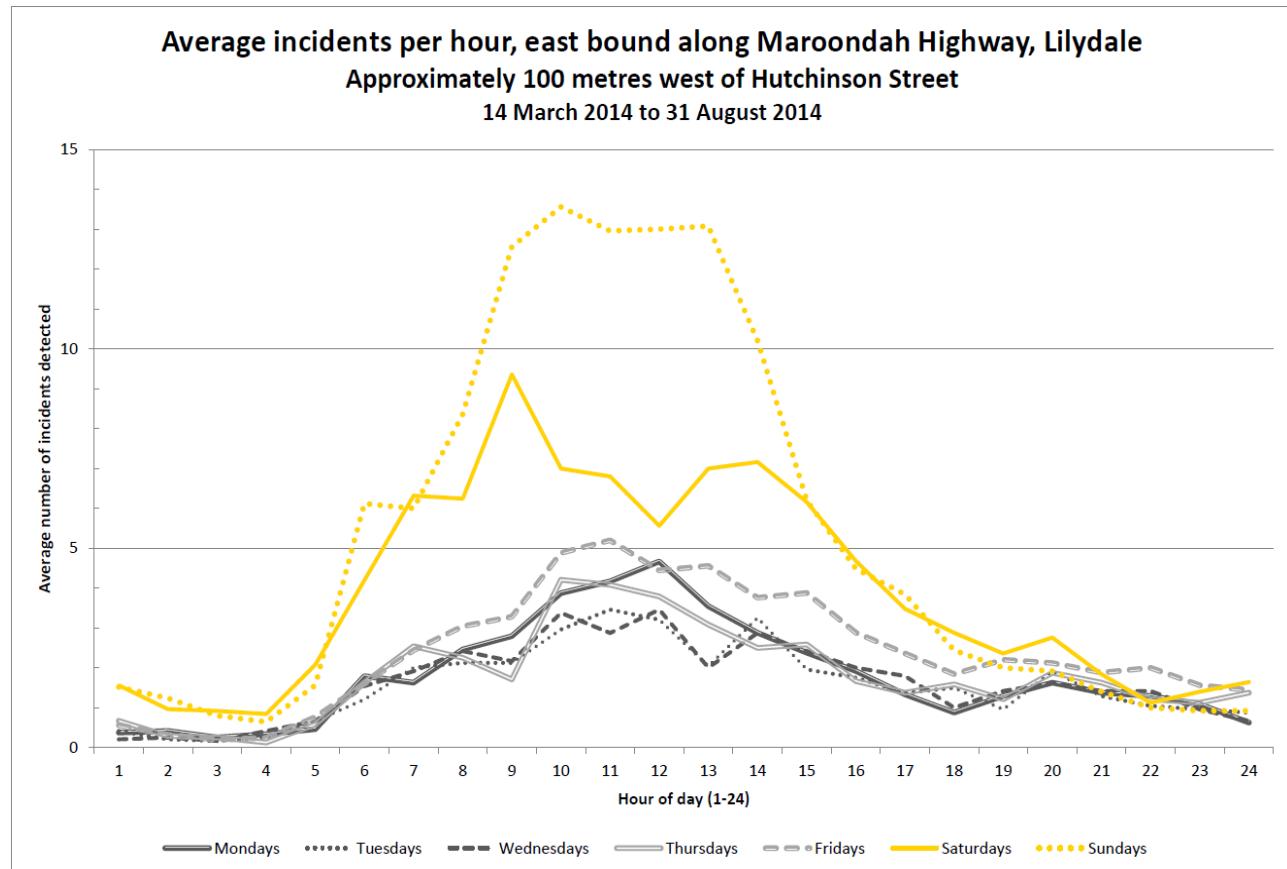
Figure D2 – Average incidents detected per hour travelling east along Maroondah High, Lilydale

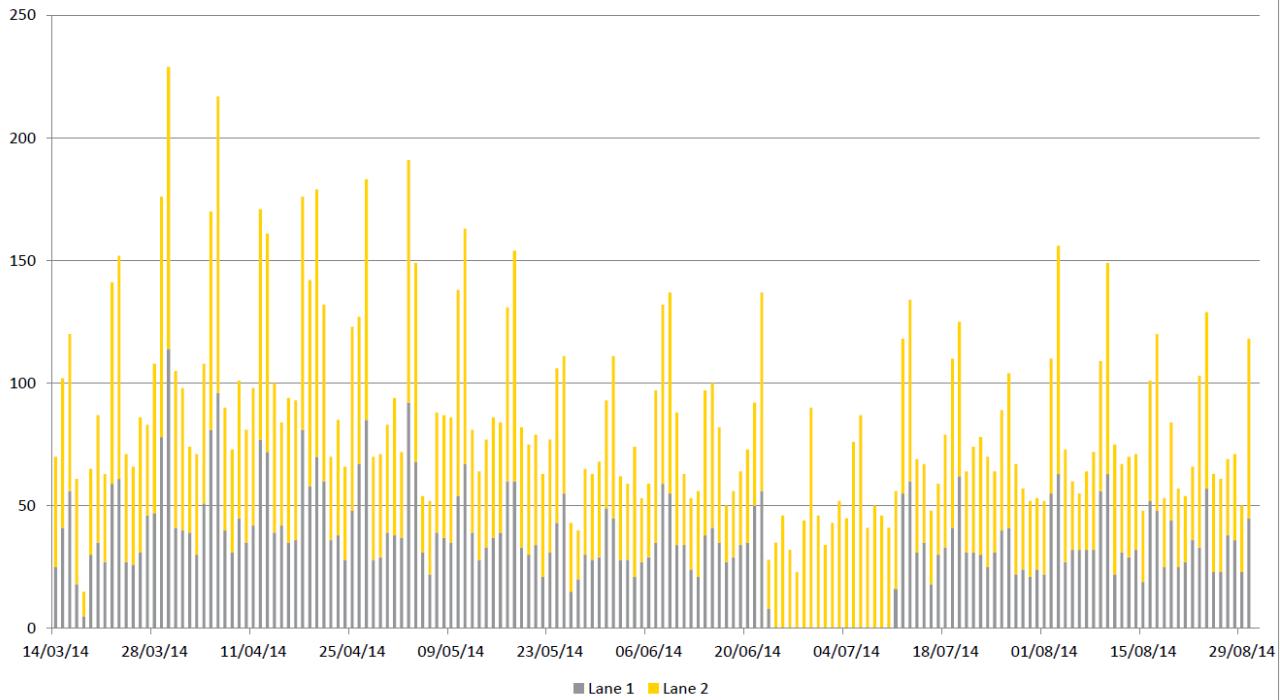
Total incidents detected, west bound along Maroondah Highway, Lilydale
Approximately 100 metres west of Hutchinson Street
14 March 2014 to 31 August 2014

Figure D3 – Daily incidents detected travelling west along Maroondah High, Lilydale

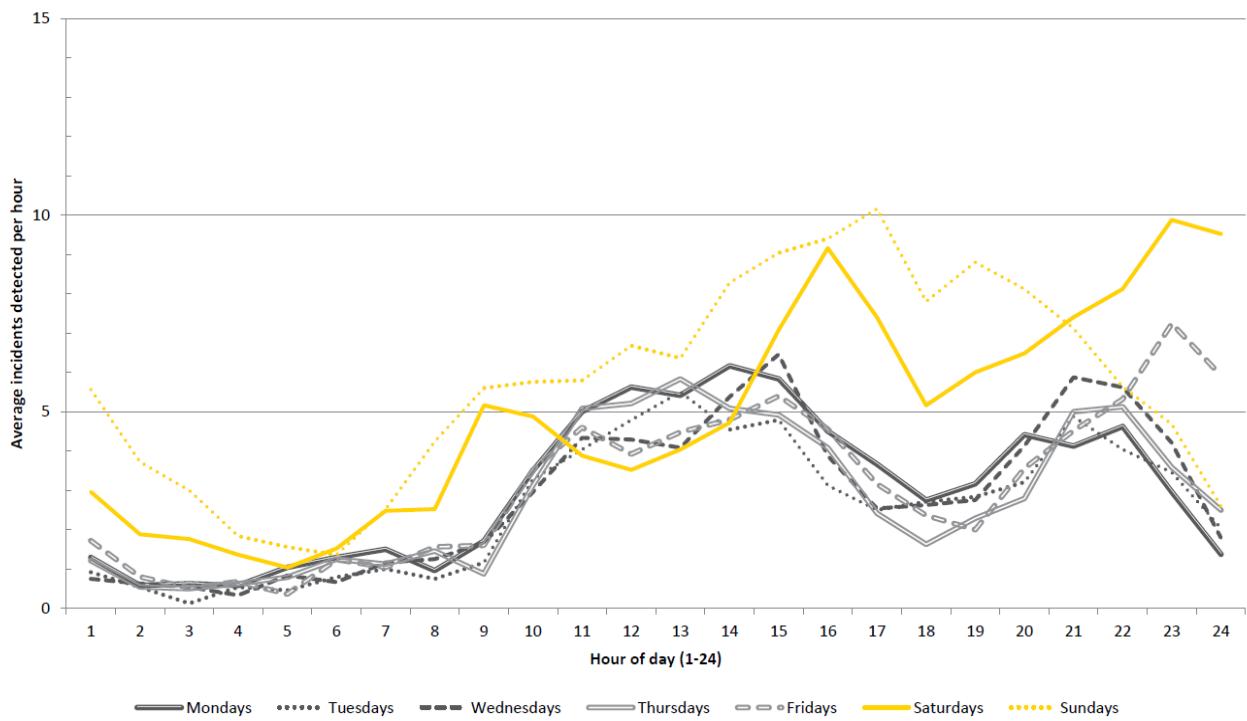
Average incidents per hour, west bound along Maroondah Highway, Lilydale
Approximately 100 metres west of Hutchinson Street
14 March 2014 to 31 August 2014

Figure D2 – Average incidents detected per hour travelling west along Maroondah High, Lilydale

- 54** Of interest also, is the second peak of detections by the road safety camera monitoring west bound traffic late during weeknights, between the hours of 8PM and 10PM, shown in **Figure D4**. Consultations with Yarra Valley Highway Patrol officers, who have also observed this phenomenon during their patrols, have led me to assume that this may be due to diners at the local restaurants and workers who typically work later at night, returning home.
